Plastic Opaque Surge Tank Staining

Field Service Product One Page Update

10/1/2025

- Freightliner Cascadia & Western Star models.

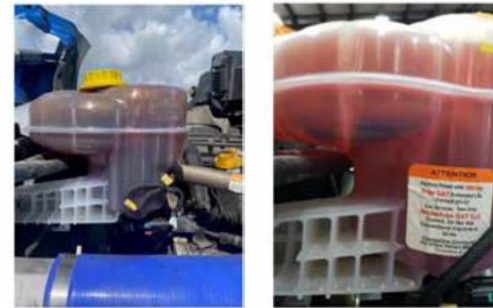
- Some units may experience an issue with a discolored coolant surge tank complaint. Units may also come in with a perception complaint of oil or combustion gas in the coolant based on the visible condition of the surge tank. The surge tank can be stained internally, making it difficult to determine the coolant level.

Through testing and analysis, deposits are consistent oxidized aluminum debris, corrosion products, and environmental dirt. The large presence of oxidized aluminum makes the deposit appear black. Ethylene glycol acts as a chelating agent, influencing the transfer of corrosion products depositing them in the surge tank. The surge tank can be stained internally, making it difficult to determine the coolant level.

The coolant filter was removed from the oil coolant module in early 2015 (review 15TS-10Rev). With the removal of this filter, any cooling system dropout may accumulate in the coolant surge tank. This allows sediment to build up in various areas of the tank and can lead to a film on the inside of the tank walls. This dropout can range from a very small number of sediment/debris up to the inability to see the coolant level through the outside of the surge tank.

Examples of discolored surge tanks

For guidelines on required action and repair procedure follow 24CSA-20 field letter communication that was released October 2024.
