FTL P4 RV 18k Front Suspension Shock Absorbers

Campaign SF 721

Published: 9/24/2025

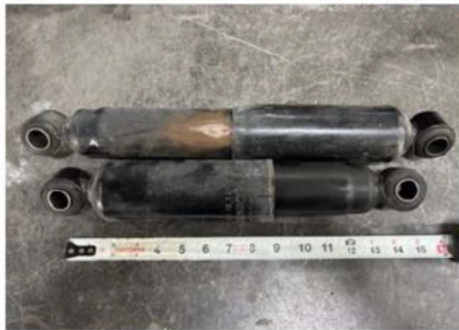
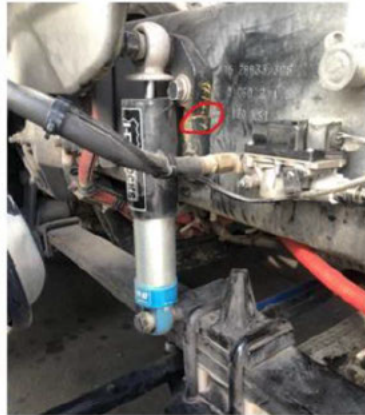
- Front shock absorbers bottoming out before full suspension travel
- Progressive damage leads to cracked upper shock bracket
- Shock absorber leaking or bent shaft

- For 18k suspension, incorrect frame rail hole locations for upper shock bracket.
- Holes need to be raised 50 mm in the vertical direction for shock absorber to have correct travel.

- New BOM 410-T00102 in design chart 410-C030 with correct drilling.
- PCHA34-BS activated 12/16/2024

- Fix-as-fail
- Update drilling location for upper shock bracket

- P67861 changeover 03/10/2025
- 410-C03048 production BOM released with correct drilling.
