WSN9- Replacing Plastic Slide On Three-Point Front Seat Belt (Workshop Campaign)

Model Line: **Macan (XAB)**

Model Year: **As of 2024 up to 2026**

Concerns: **Three-point front seat belt on passenger side**

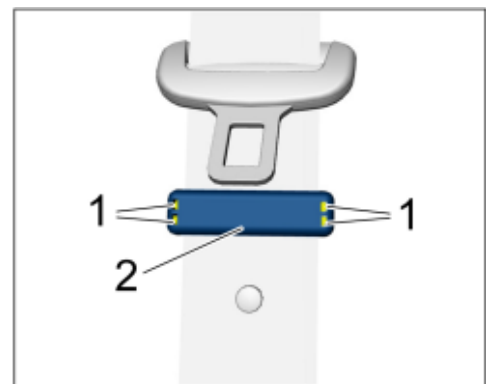
Plastic slide without belt loop

Cause: **On the affected vehicles, there is a possibility that on the passenger side rattling noises could occur on the B-pillar due to the free-swinging belt tongue of the three-point seat belt.**

- Work Procedure:
- 1 Loosen retaining lugs ⇒ *Plastic slide without belt loop*
 -1- on the plastic slide ⇒ *Plastic slide without belt loop*
 -2- using a suitable tool, ⇒ *Plastic slide without belt loop*
 -2- open plastic slide and remove.
 - 2 Fasten **new** plastic slide with belt loop ⇒ *Plastic slide with belt loop*
 -1- to belt strap. Make sure that the belt loop under the belt tongue is pointing ⇒ *Plastic slide with belt loop*
 -2- upwards.
