Technical Information

ASA2 - Replace Front Seat Cushion (Passenger Side) (Recall Campaign)

Model Line: Taycan (Y1A/Y1B/Y1C)

Model Year: As of 2022 up to 2023

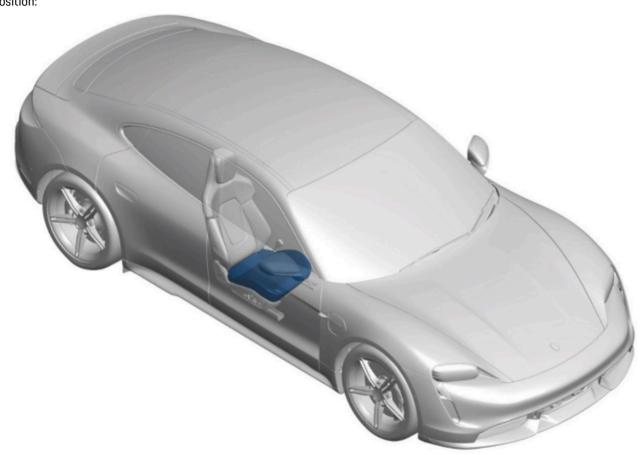
Cause: Due to a faulty crimping connection of the seat cushion heating, the seat occupancy detection for

the passenger side can activate a failsafe mode that deactivates the airbag on the passenger seat. If the activated airbag warning signal or the warning message "passenger airbag OFF" is ignored by the passenger and the passenger does not move to another seat position or leaves the vehicle, the protection of the front airbag system is not fully available to the passenger in the event of an accident. This increases

Installation position of seat cushion with integrated seat occupancy detection

Action: Replaced the seat cushion with the integrated seat occupancy detection (passenger side).
