WSN9- Replacing Plastic Slide On Three-Point Front Seat Belt (Workshop Campaign)

Model Year: **As of 2024 up to 2026**

Model Line: **Macan (XAB)**

Concerns: **Three-point front seat belt on passenger side**

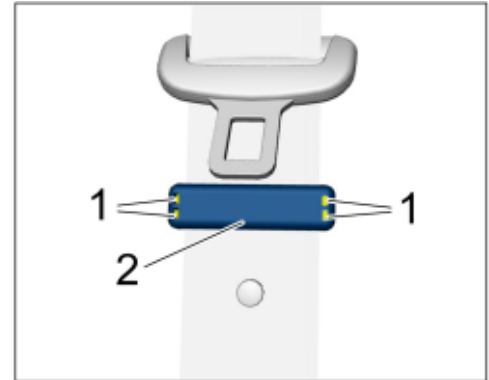
Plastic slide without belt loop

Cause: **On the affected vehicles, there is a possibility that on the passenger side rattling noises could occur on the B-pillar due to the free-swinging belt tongue of the three-point seat belt.**

- Work Procedure:
- 1 Loosen retaining lugs \Rightarrow *Plastic slide without belt loop -1-* on the plastic slide \Rightarrow *Plastic slide without belt loop -2-* using a suitable tool, \Rightarrow *Plastic slide without belt loop -2-* open plastic slide and remove.
 - 2 Fasten **new** plastic slide with belt loop \Rightarrow *Plastic slide with belt loop -1-* to belt strap. Make sure that the belt loop under the belt tongue is pointing \Rightarrow *Plastic slide with belt loop -2-* upwards.
