WSN5 - Rework Damper Element Screw Connection (Workshop Campaign)

Vehicle Type: **911 GT3 (992)**
911 GT3 RS (992)
911 S/T (992)

Model Year: **As of 2024 up to 2025**

Concerns: **Screw connection for damper element**

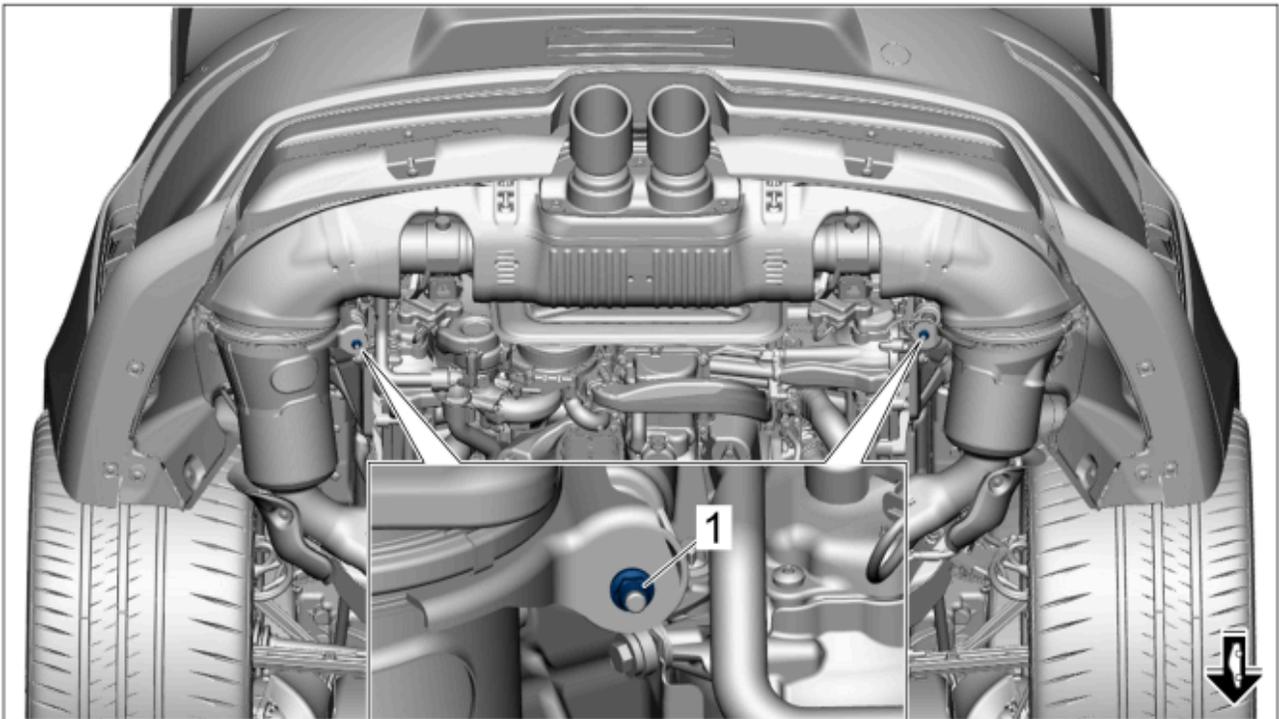
Reworking screw connection for damper element

Cause: **The damper elements of the catalytic converter brackets may not have been screwed correctly on the affected vehicles.**
 This leads to increased vibrations and forces on the exhaust manifold, which can cause cracks and consequently significant noise developments in the area of the exhaust system over the vehicle's service life.

- Work Procedure: 1 Remove rear spoiler, lower part (diffuser).
⇒ *Workshop Manual '665919 Removing and installing rear spoiler, lower part (diffuser)'*
- 2 Nut for damper element ⇒ *Reworking screw connection for damper element -1-* on both sides of the vehicle with **Tightening torque 26 Nm (19.2 ftlb.)**
