WSN9- Replacing Plastic Slide On Three-Point Front Seat Belt (Workshop Campaign)

Model Year: **As of 2024 up to 2026**

Model Line: **Macan (XAB)**

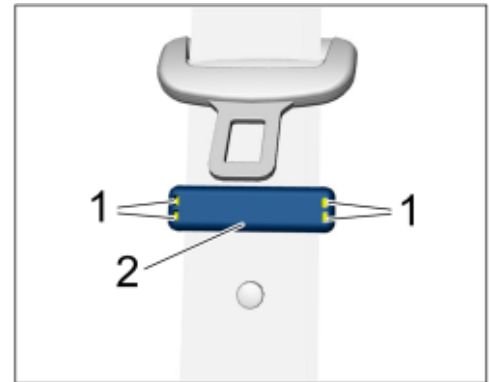
*Plastic slide without belt loop*

Cause: **On the affected vehicles, there is a possibility that on the passenger side rattling noises could occur on the B-pillar due to the free-swinging belt tongue of the three-point seat belt.**

- Work Procedure:
- 1 Loosen retaining lugs \Rightarrow *Plastic slide without belt loop -1-* on the plastic slide \Rightarrow *Plastic slide without belt loop -2-* using a suitable tool, \Rightarrow *Plastic slide without belt loop -2-* open plastic slide and remove.
 - 2 Fasten **new** plastic slide with belt loop \Rightarrow *Plastic slide with belt loop -1-* to belt strap. Make sure that the belt loop under the belt tongue is pointing \Rightarrow *Plastic slide with belt loop -2-* upwards.
