## 167 MOPF, 254, 206, 214, 236 with M254 and 725.1 with Harsh 5to4 downshift

Topic number	LI27.60-P-079968
Version	1
Function group	27.60 - Gearshift, control
Date	11/4/25
Validity	167 MOPF, 254, 206, 214, 236 with Engine M254 and Transmission 725.1
Reason for change

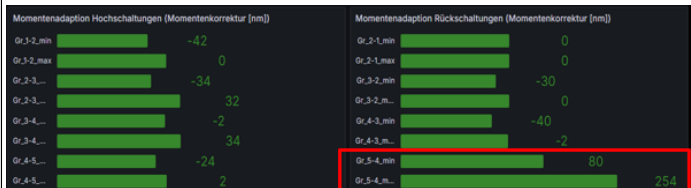
<a href="#">Momentenadaption_Torque-Adaptation.png</a>	Torque Adaptation

A harsh 5-4 downshift can be felt during deceleration while braking or coasting. It may be mistaken for a hard brake engagement

Poor learning of brake B06 adaptation values over time.
