# Technical Service Bulletin

<b>Topic</b>	Tyre tread/sidewall crack(s)
<b>Market area</b>	Australia E04 Bentley rest Asia and Australia (6E04),China 723 Volkswagen (Anhui) Automotive CO (6723),China 796 VW Import Comp. Ltd (Vico), Beijing (6796),Germany E02 Bentley rest Europe (6E02),Japan E03 Bentley Japan (6E03),Korea, (South) E08 Bentley South Korea (6E08),United Arab Emirates E06 Bentley Middle East and Africa (6E06),United Kingdom E01 Bentley UK (6E01),United States E05 Bentley USA and rest America (6E05)
<b>Brand</b>	Bentley
<b>Transaction No.</b>	2063651/5
<b>Level</b>	EH
<b>Status</b>	Released for publishing
<b>Release date</b>	Sep 24, 2025

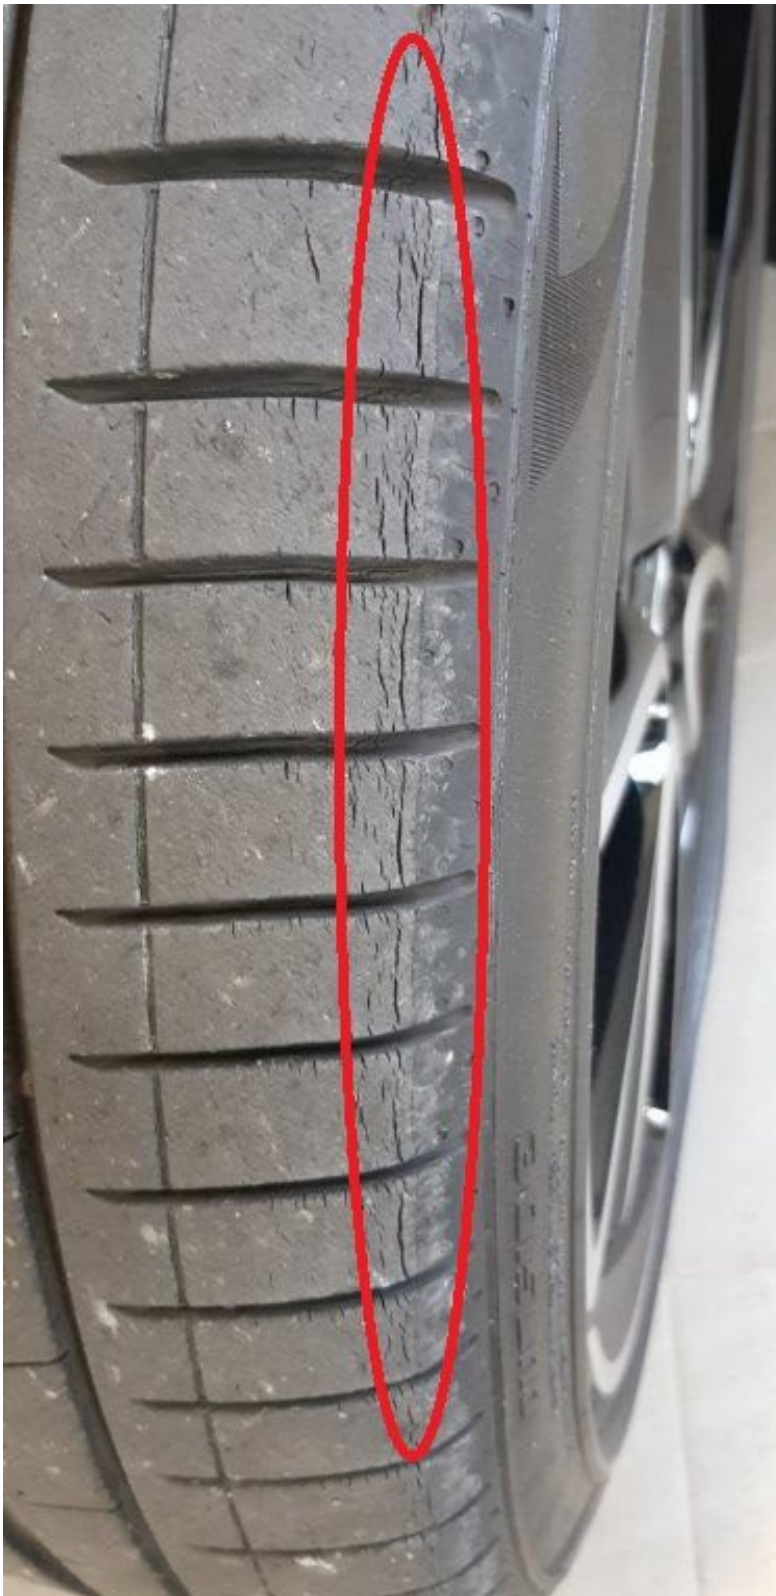
Figure 1

Cracks evident in the sidewall and/or tread pattern (See the examples in Figures 1 and 2 showing cracks within the tread pattern)

The issue is mainly evident on vehicles with very low usage

This is a result of the tyre compound hardening due to the following:

- Tyre age
- Tyre pressure not adjusted to specification
- Low mileage/vehicle usage
- Vehicle storage conditions

When cars are found to be at low mileage or have not been used regularly for an extended period of time, the oils and compound of the rubber can dry up due to a lack of repeated compression, this can lead to compound separation.
