Technical Service Bulletin

Topic	Bentley Rotational Display (BRD) clashing with the switch pack during rotation
Market area	Bentley: worldwide (2WBE),China 796 VW Import Comp. Ltd (Vico), Beijing (6796)
Brand	Bentley
Transaction No.	2075740/2
Level	EH
Status	Released for publishing
Release date	Sep 24, 2025

New Continental GT / C and New Flying Spur

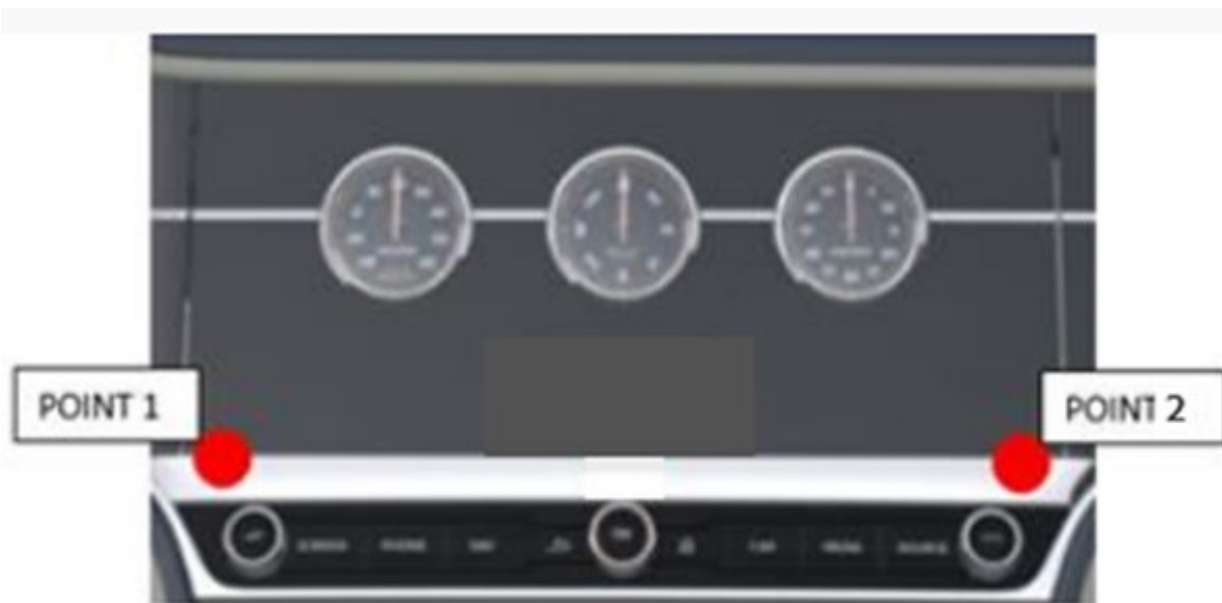
Bentley Rotational Display (BRD) clashing with the MMI switch pack during rotation

1) Conduct a visual inspection of all (3) BRD faces checking for any signs of clashing / damage at the locations shown in Figure 1 (POINT 1 and POINT 2)

Should any issues be evident with the BRD faces or MMI switch pack the operative must raise a technical DISS query and await feedback before conducting any further work

- Should no issues be evident please continue with the remaining instructions
