# Technical Service Bulletin

<b>Topic</b>	Foremost lower trailing arm bush leaking
<b>Market area</b>	Australia E04 Bentley rest Asia and Australia (6E04), China 723 Volkswagen (Anhui) Automotive CO (6723), China 796 VW Import Comp. Ltd (Vico), Beijing (6796), Germany E02 Bentley rest Europe (6E02), Japan E03 Bentley Japan (6E03), Korea, (South) E08 Bentley South Korea (6E08), Russian Federation 935 Volkswagen Group RUS (6935), United Arab Emirates E06 Bentley Middle East and Africa (6E06), United Kingdom E01 Bentley UK (6E01), United States E05 Bentley USA and rest America (6E05)
<b>Brand</b>	Bentley
<b>Transaction No.</b>	2069159/2
<b>Level</b>	EH
<b>Status</b>	Released for publishing
<b>Release date</b>	Sep 24, 2025

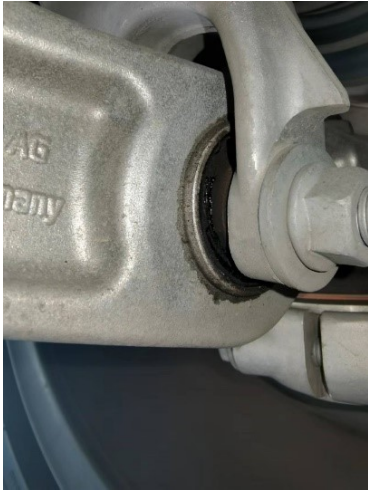
Figure 1

Leakage found on the foremost lower trailing arm bush as shown in Figures 1 and 2

In the event leakage is found on the foremost lower trailing arm bush as shown in Figures 1 and 2 the operative should conduct the onward instructions

- Conduct a thorough inspection of the suspension and steering systems including the underfloor to confirm if there is any signs of impact or damage
- Confirm if there is any signs of impact or damage to the lower front control arm and/or bush
- Confirm if there are any complaints of 'clicking' emanating from the foremost lower trailing arm bush

- **The foremost lower trailing arm bush should not be replaced for the symptom described unless the bush is worn / damaged or an acoustic concern is present**
- **The lower front control arm should be cleaned using a suitable cleaning solution if none of the aforementioned symptoms are not present**
