Technical Service Bulletin

| Topic | Front carpets / Mats wet - Musty smell in the cabin - Suspected leak from the water and condensate drains |
| Transaction No. | 2075712/2 |

New Continental GT/C and New Flying Spur

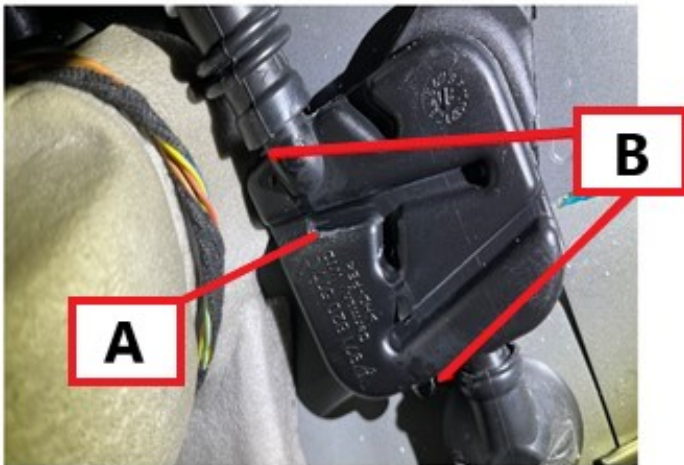
- Allow the engine to idle for 5 minutes
- Referring to Figure 4 - After 5 minutes has elapsed
- Check the left and right hand condensate drains for signs of moisture residue stains (A)
- Check the hoses for signs of water leaks (B)

In the event that water is leaking from the condensate drain hoses at the points shown in Figure 4 or moisture residue stains are evident the operative should conduct the remaining instructions from step 4 on the left and right hand side
