Technical Service Bulletin

Topic	Front Seat Squab Creak
Market area	Bentley: worldwide (2WBE)
Brand	Bentley
Transaction No.	2076720/2
Level	EH
Status	Released for publishing
Release date	Sep 24, 2025

25MY Continental GT/GTC

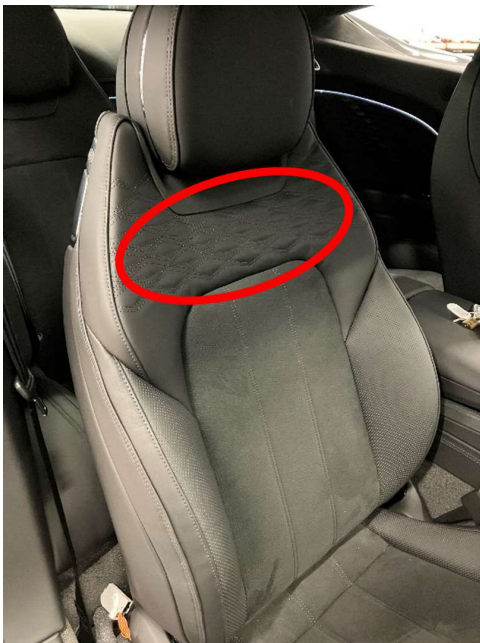
Figure 1

The noise source is the Bowden cable for the squab dump mechanism to the wellness PA mouldings. The noise will appear to come from the front seat squab (Figure 1).

The root cause is due to incompatible materials pairing and a poorly retained Bowden cable, due to the geometry of the retaining hooks.
