Technical Service Bulletin

Topic	Grease evident at the front lower ball joint bellows
Market area	Bentley: worldwide (2WBE),China 796 VW Import Comp. Ltd (Vico), Beijing (6796)
Brand	Bentley
Transaction No.	2074957/3
Level	EH
Status	Released for publishing
Release date	Sep 24, 2025

New Continental GT / C and New Flying Spur

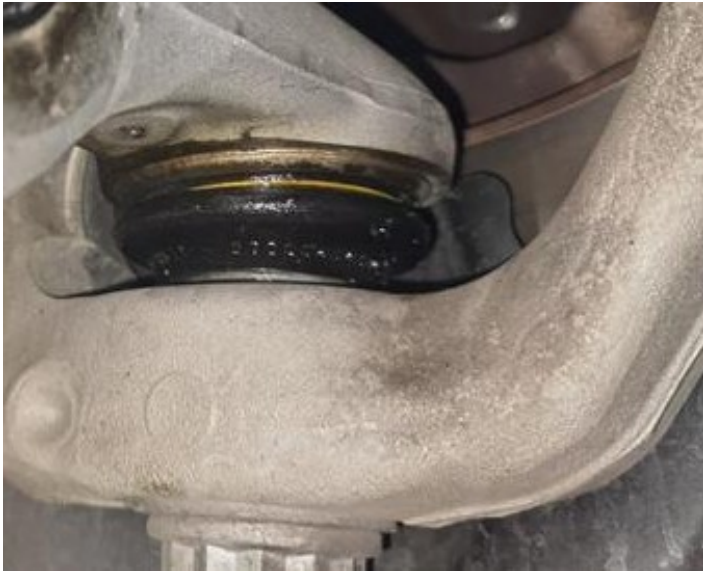
Figure 1

The level of grease on or around the lower ball joint boot/wheel bearing housing (Figures 1,2 and 3) is deemed as a normal characteristic

“Normal” Characteristic:

If there is no customer complaint about noises (rattling, pinching, creaking) from the area of the front axle and the lower levers have clearance, the operative must remove any excess grease and check the ball joint and bellows for damage

If the ball joint/bellows is not damaged, the lower lever does not need to be replaced

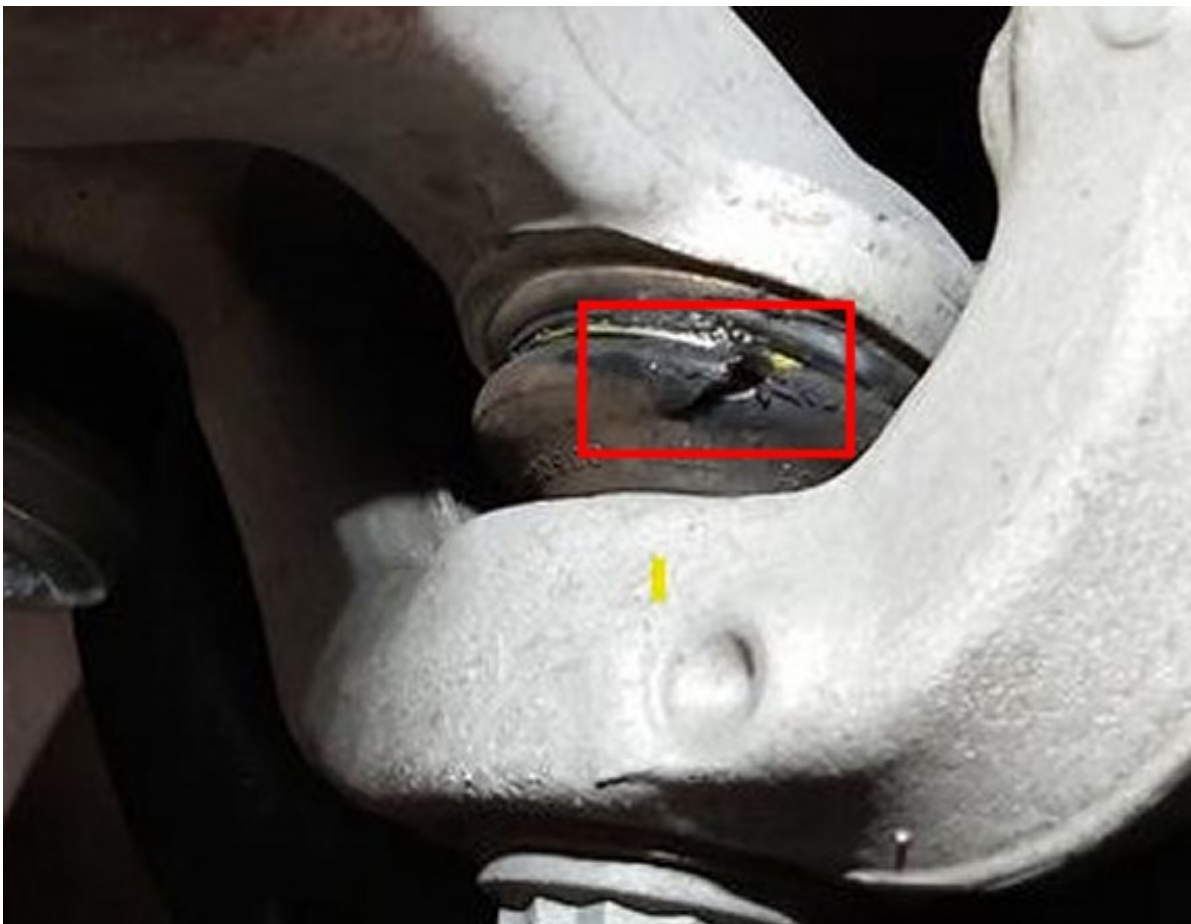
Figure 4

“Torn/split bellows” - Replacement necessary

If the ball joint is worn/damaged or the ball joint bellows is split/damaged (as shown in Figures 4 and 5) the lower front lever must be replaced – Refer to Rep.Gr 40

IMPORTANT: Prior to replacing the lower lever the operative **MUST** raise a Technical DISS query requesting permission to replace the front lower lever
