Technical Service Bulletin

Topic	New Continental GT/GTC & Flying Spur Front and Rear Exterior Lighting Steamed Up /Leaks
Market area	Bentley: worldwide (2WBE),China 796 VW Import Comp. Ltd (Vico), Beijing (6796)
Brand	Bentley
Transaction No.	2076754/2
Level	EH
Status	Released for publishing
Release date	Sep 24, 2025

25MY Continental GT/GTC & Flying Spur

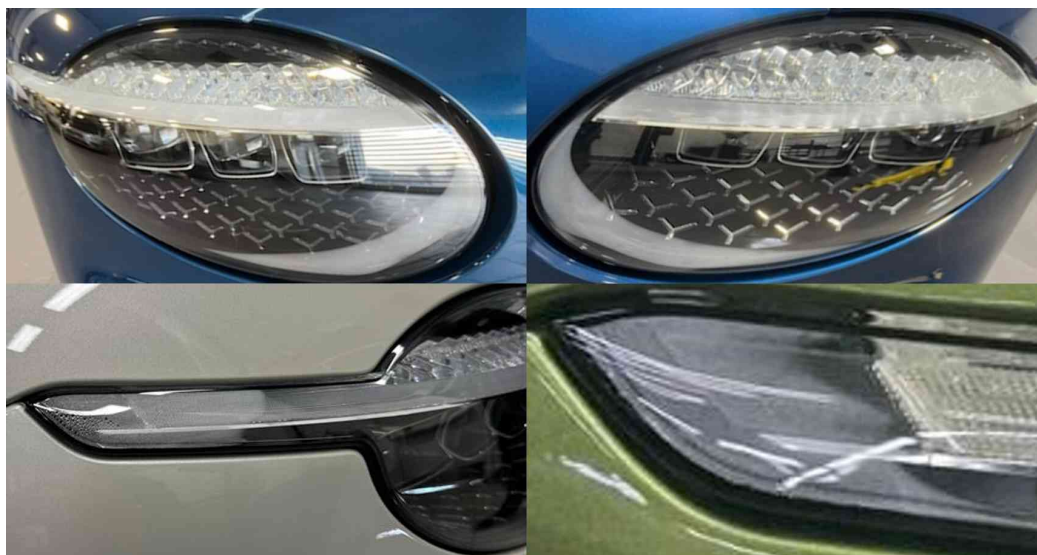
Figure 1a – Front headlights steamed up/damp from the inside with minor drips

Customer statement for 1 (Figure 1): The lens of the headlight, front fog lamp or tail light are steamed up /damp from the inside with minor drips.

1. Damp air settles on the inner lens of the headlights, tail lights or fog lamps, with recognisable misting in certain weather conditions
2. There is a leak on the headlights, tail lights or fog lamps. For example through open covers, a damaged seal of the cap or similar.

1. In case of a complaint, the light emission surface on the lens must be clear after a journey of 5-10 minutes with sufficient ventilation (for example country road/motorway) and switched-on dipped beam.

The remaining inside surfaces may still have some condensation on them after the drive; this is not a problem.

NOTE: This is normal, in this case, replacement of the headlights/tail lights will NOT fix the problem and lead to a repeat repair.

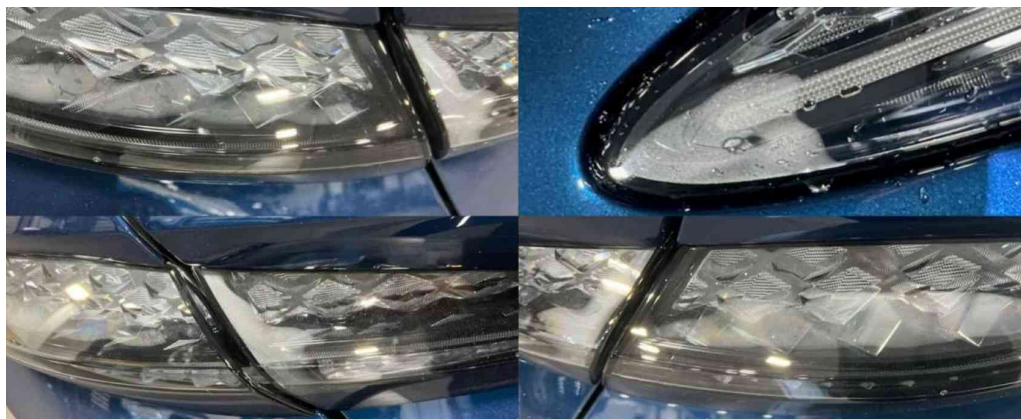
Figure 1b – Rear tail lights steamed up/damp from the inside with minor drips

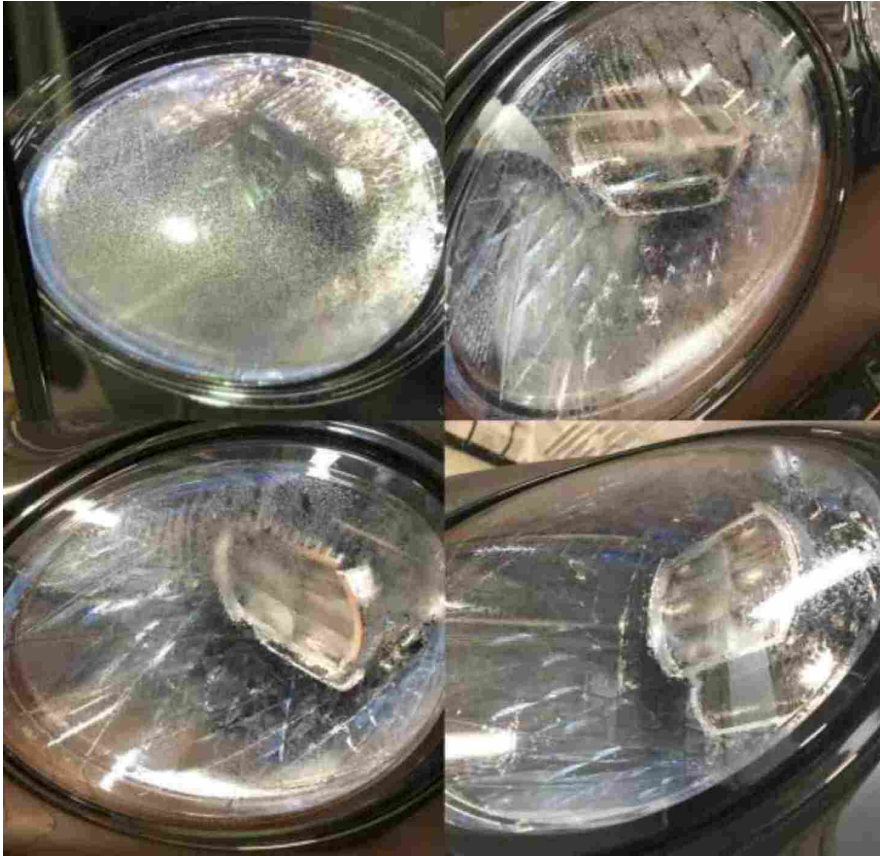
Figure 2 – Water is in the headlights as water marks/large droplets.

Customer statement for 2 (Figure 2): Water is in the headlight, front fog lamp or tail light as big droplets on the complete lens. There is a leak on the headlight, front fog lamp or tail light.

2. In case of an obvious water ingress/leak (a lot of drips on the inside of the lens, Figure 2) use the test plan attached to establish the cause.

Dry the effected light afterwards with filtered, oil-free compressed air.

In case of water ingress (damaged seal, lens and so on) perform the appropriate repairs according to the repair manual/parts catalogue and check whether the connectors or connections of any control units fitted, are damaged by corrosion.
