Technical Service Bulletin

Topic	Outer dashboard speaker grille lifted / Incorrect flushness
Market area	Bentley: worldwide (2WBE),China 796 VW Import Comp. Ltd (Vico), Beijing (6796)
Brand	Bentley
Transaction No.	2075601/3
Level	EH
Status	Released for publishing
Release date	Sep 24, 2025

New Continental GT / C and New Flying Spur

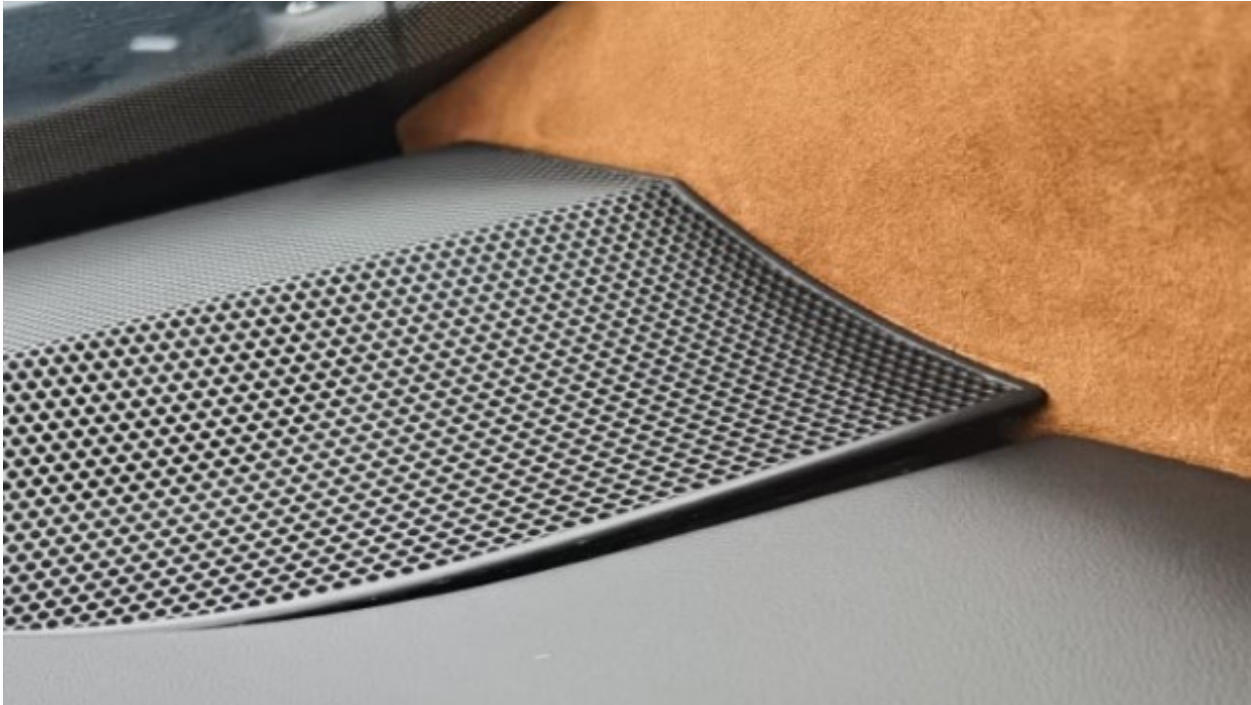
Figure 1

Outer demister panel (speaker grille) lifted / Incorrect flushness (Figure 1)

- In the event the issue is as described please refer to the Measure section

- 4) With care remove and discard the original clip
- 5) Fit a new clip (See parts information section)
- 6) Refit the demister panel back into position Note: When refitted correctly the demister panel clip should click / lock into position
