## Technical Service Bulletin

<b>Topic</b>	Rattle / Creak from the dashboard demister panel
<b>Market area</b>	Bentley: worldwide (2WBE),China 796 VW Import Comp. Ltd (Vico), Beijing (6796)
<b>Brand</b>	Bentley
<b>Transaction No.</b>	2075693/3
<b>Level</b>	EH
<b>Status</b>	Released for publishing
<b>Release date</b>	Sep 24, 2025

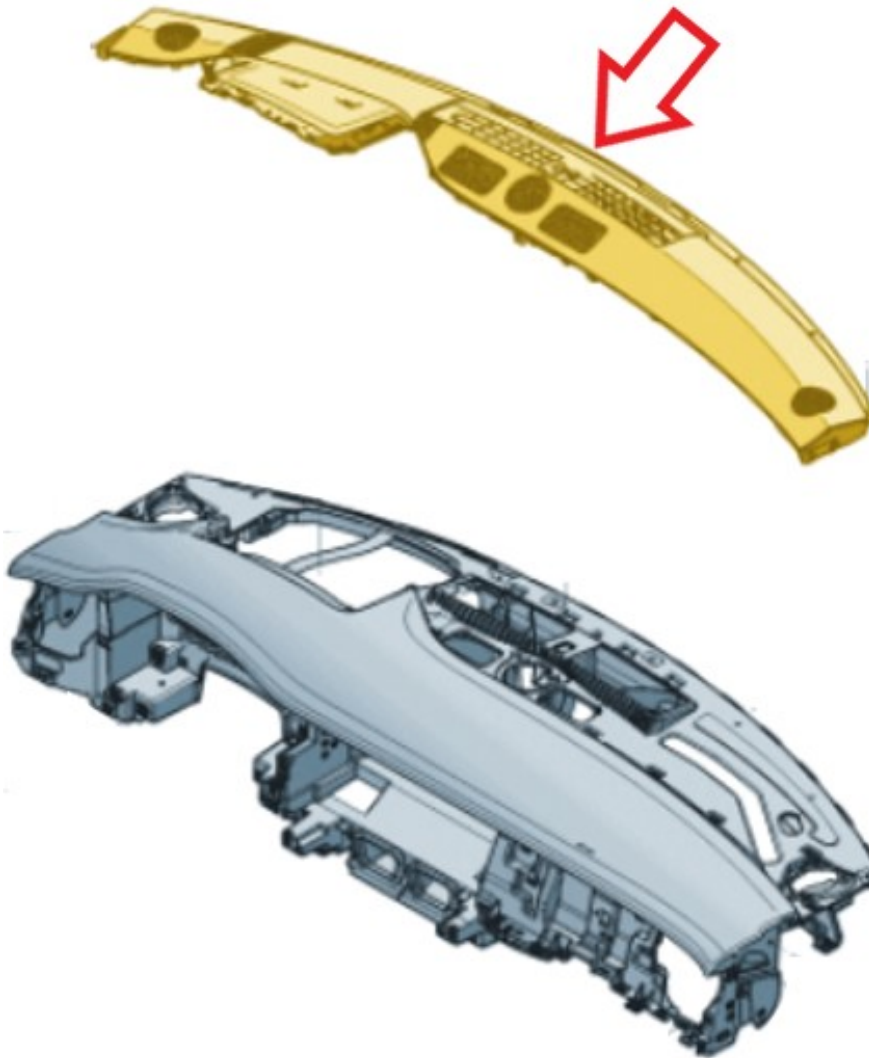
Figure 1

Rattle / Creaking noise from the dashboard demister panel (Figure 1)
