Technical Service Bulletin

Topic	Water ingress into the front cabin footwell/bulkhead - Glass misting on the inside - Front carpets/mats wet
Market area	Bentley: worldwide (2WBE),China 796 VW Import Comp. Ltd (Vico), Beijing (6796)
Brand	Bentley
Transaction No.	2075713/2
Level	EH
Status	Released for publishing
Release date	Sep 24, 2025

New Continental GT / C and New Flying Spur

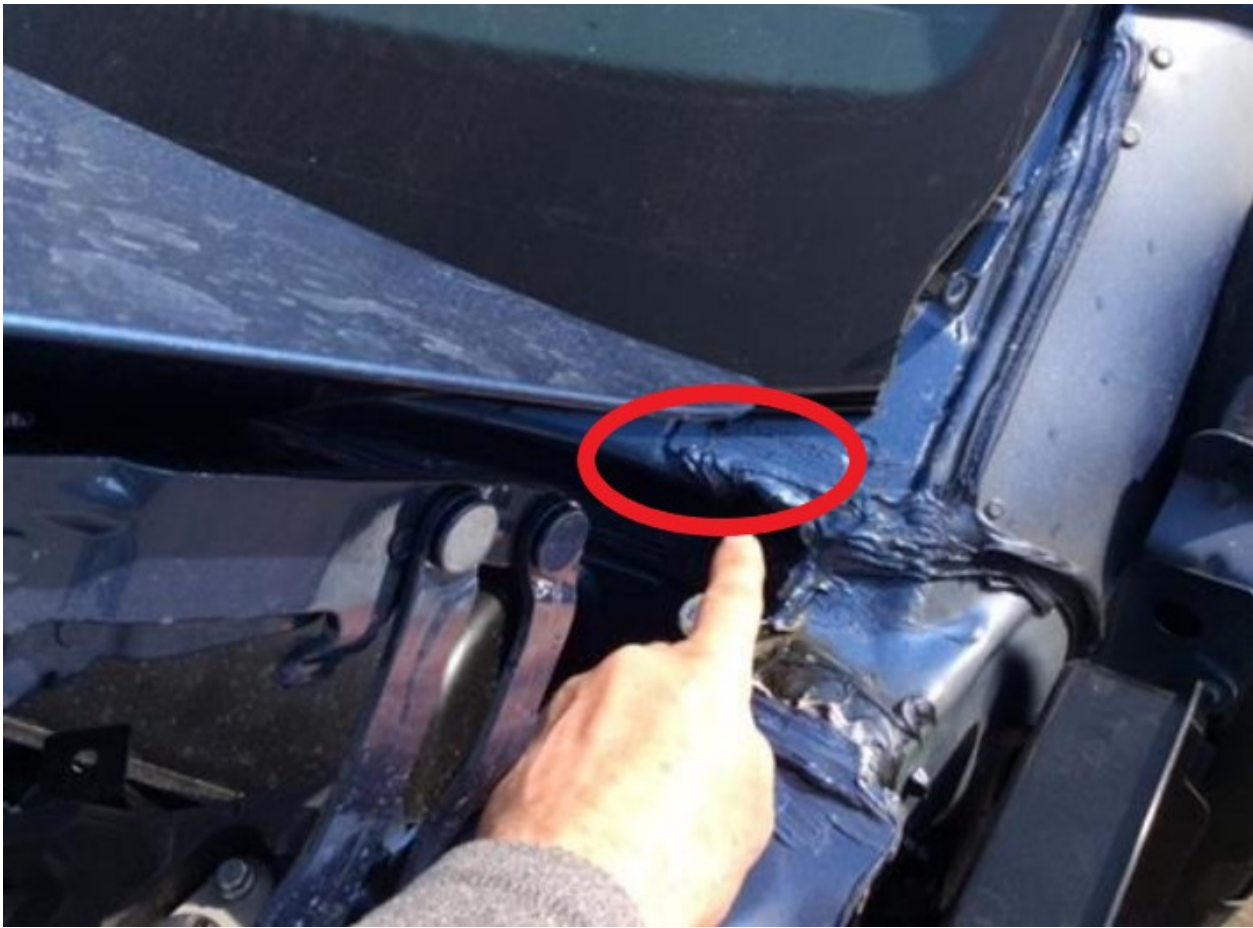
- After conducting TPI 2062622/- water ingress was found at the location shown in Figure1 (Left hand A - Pillar seam)

Figure 1 - Shows the front left hand wing removed please note this is not required for this procedure unless advised via a new or existing DISS query

Hint: The example shows a leak on the left hand side although a leak could be evident on the right hand side at the same location

- 1) Referring to Rep.Gr 55 - Remove the plenum cover
 - Check the condition of the seam sealant at the location shown in Figures 1 and 2
 - Check to confirm that sealant has been applied to the left hand A - pillar seam
 - Check to confirm that sealant has been applied to the right hand A - pillar seam

A different location the operative should clean/prepare the areas concerned and apply sealant (See parts information) to the applicable location(s)

- Once sealant has been applied conduct a local paint repair in the location in which sealant was missing

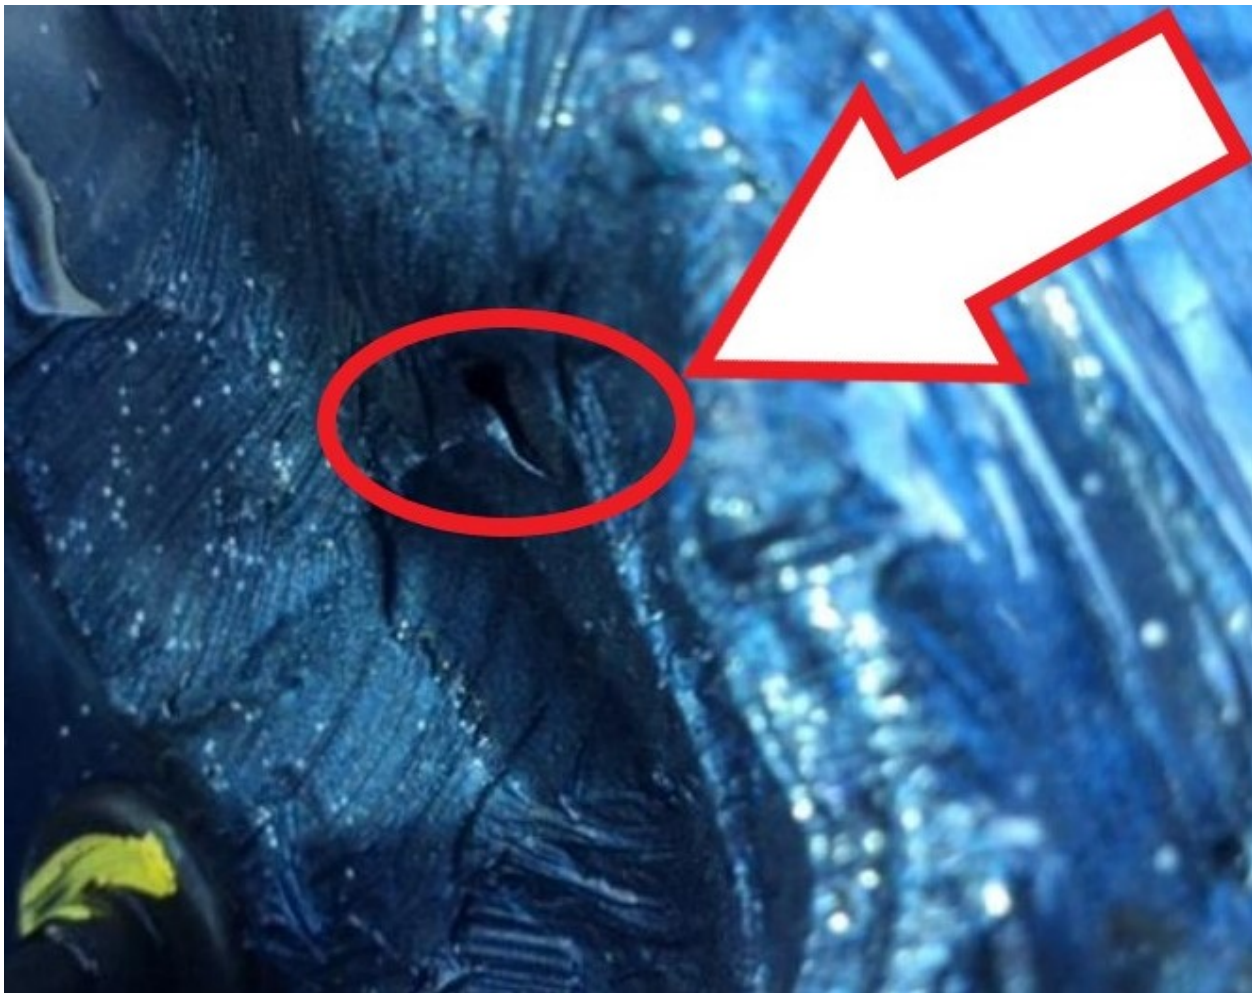
Figure 2

- The cause of the ingress can be caused by missing sealant on the A - post pillar seam
