Technical Service Bulletin

Topic	Windscreen replacement criteria whilst under manufacturers warranty
Market area	Bentley: worldwide (2WBE),China 796 VW Import Comp. Ltd (Vico), Beijing (6796)
Brand	Bentley
Transaction No.	2074961/3
Level	EH
Status	Released for publishing
Release date	Sep 24, 2025

New Continental GT / C and New Flying Spur

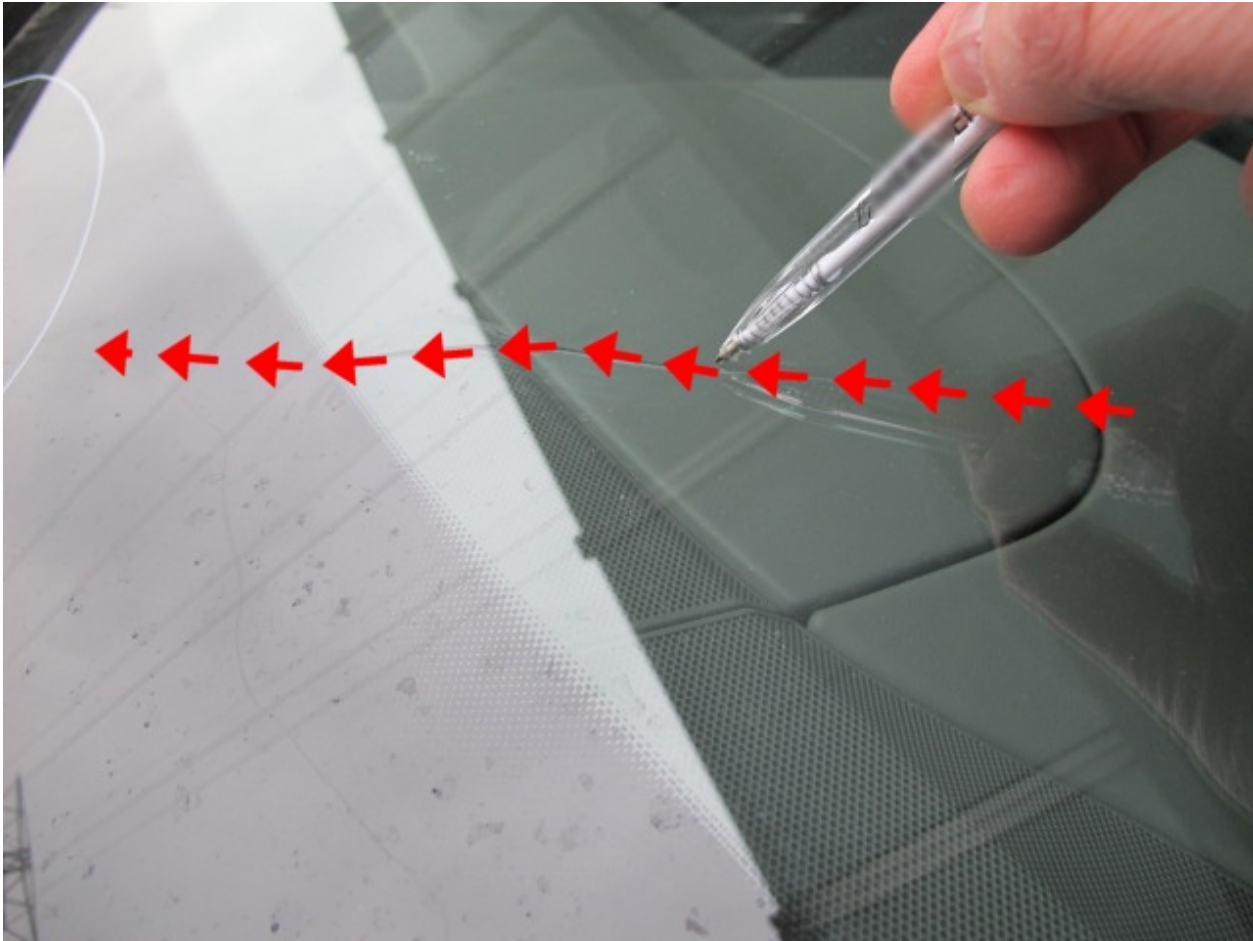
Figure 1

TIP: A "pen test" can be used to determine if there is a stress crack evident, a ballpoint pen tip is run along the crack (Figure 1), in the event the tip of the pen dips at any point along the crack this MUST be classed as damage from external influences

Should the pen not dip this can **possibly** be considered as a stress crack

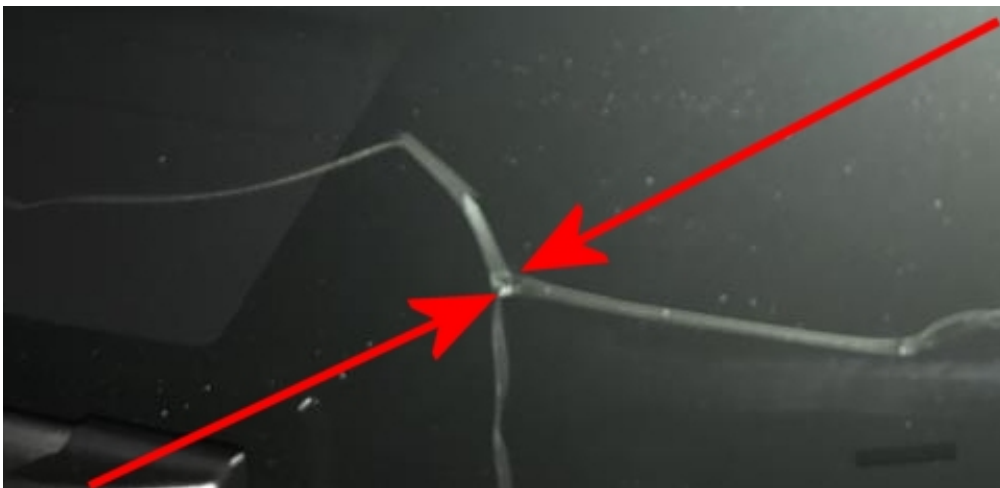
In the event that the windscreen has been identified as cracked/damaged through impact (See Figure 2 as an example), this would NOT be covered under the Bentley Motors Warranty policy, therefore the windscreen MUST be replaced, the cost of replacement would not be covered by Warranty

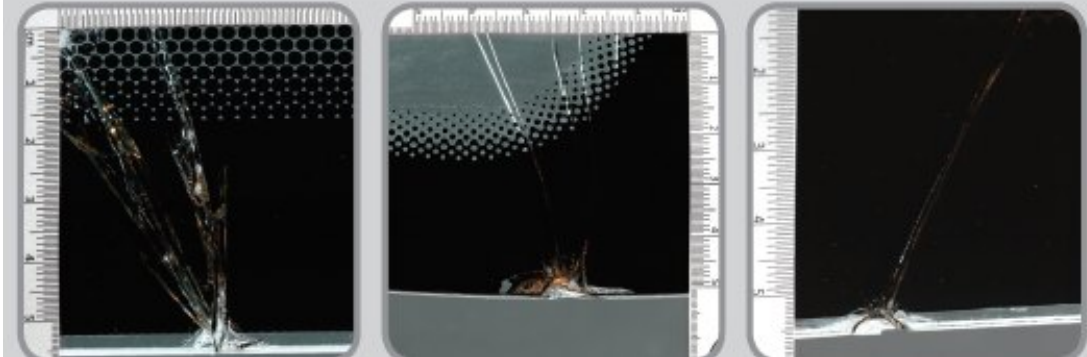
- Refer to the example shown in Figure 3 which details glass edge damage

Glass shelling / glass detached on glass edge. Depending on the force involved, there may be only a little, some or significant radial cracking of the glass from the edge damage, which may be difficult to see because of the black print on the glass.

Glass Edge.

Damaged during assembly to the vehicle. Impact to glass edge (exposed edges e.g. A-post, top of glass)

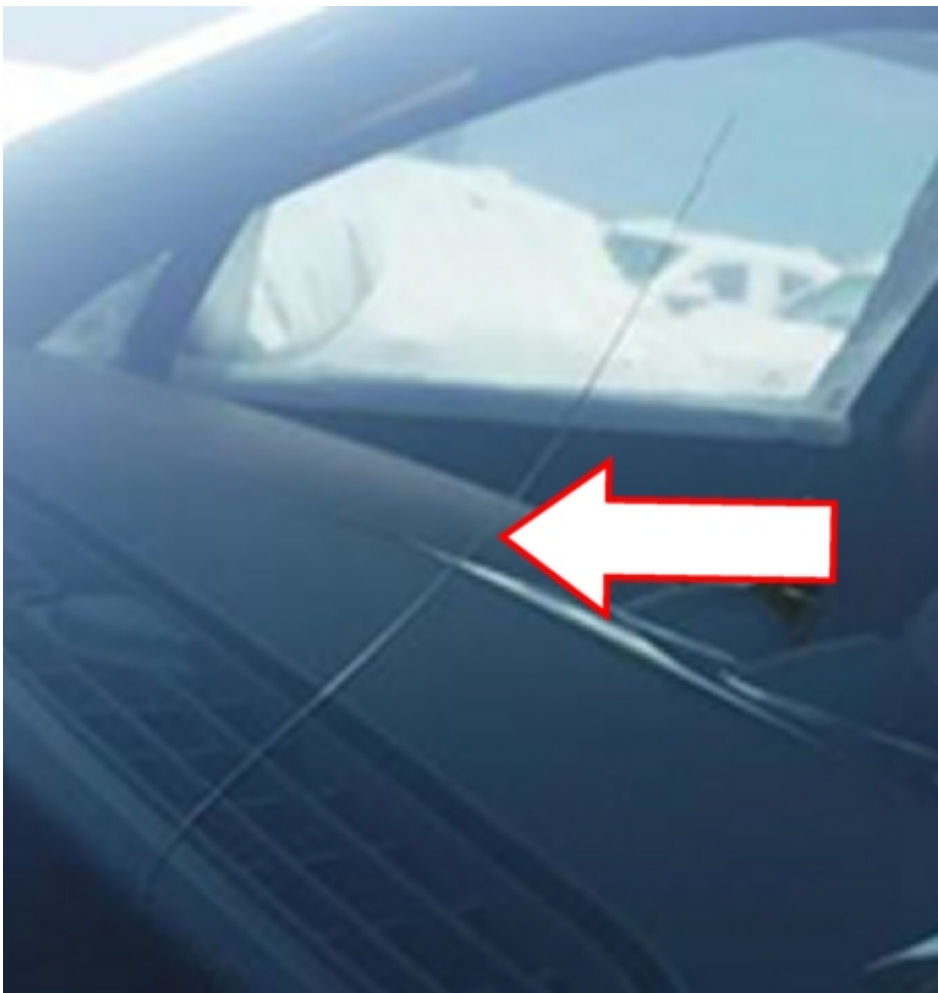
In the event the screen has been identified as cracked/damaged through a stress fracture (See Figure 4 as an example) and the vehicle is covered by manufacturers/extended warranty the retailer MUST carry out the following instructions

- Damaged windscreens MUST be reported as per the Mandatory DISS reporting policy
- A DISS query must be raised, the retailer MUST not carry out windscreen replacement or removal until permission has been granted through the open DISS query ***NOTE: Product Support may request the screen is removed for further diagnosis***
- The retailer must ensure that the following information is attached within the query
- Clear photographs of the crack/damage
- Clear description of the location in which the crack/damage is emitting from for example: Right hand front corner
- Video to be attached to the DISS query clearly showing the tip of a ball point pen being run along the length of the suspected crack
