## Technical Service Bulletin

<b>Topic</b>	Tyre tread/sidewall crack(s)
<b>Market area</b>	Bentley: worldwide (2WBE),China 796 VW Import Comp. Ltd (Vico), Beijing (6796)
<b>Brand</b>	Bentley
<b>Transaction No.</b>	2074967/3
<b>Level</b>	EH
<b>Status</b>	Released for publishing
<b>Release date</b>	Sep 24, 2025

### New Continental GT / C and New Flying Spur

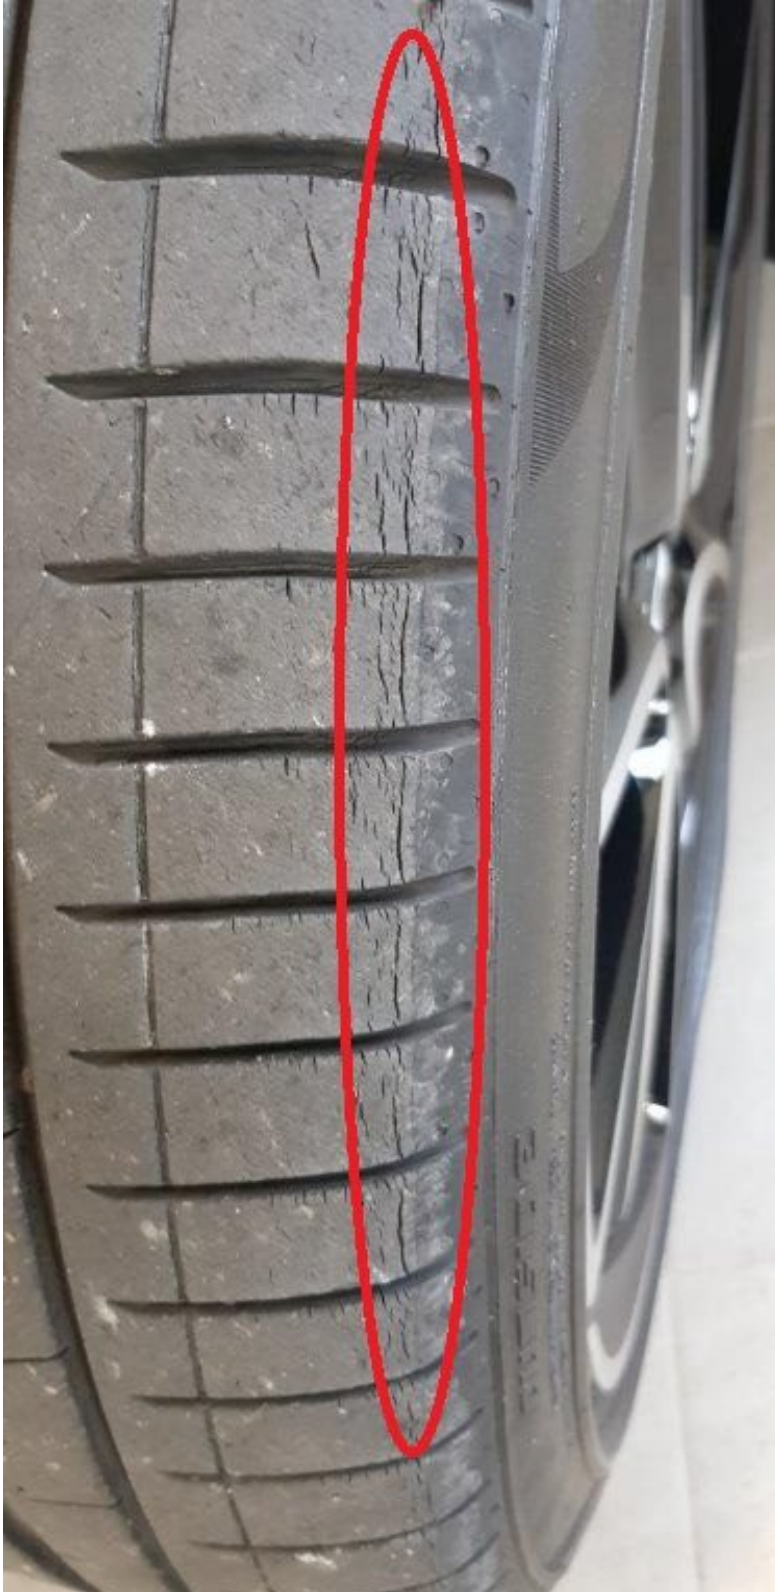
Figure 1

Cracks evident in the sidewall and/or tread pattern (See the examples in Figures 1 and 2 showing cracks within the tread pattern)

The issue is mainly evident on vehicles with very low usage

This is a result of the tyre compound hardening due to the following:

- Tyre age
- Tyre pressure not adjusted to specification
- Low mileage/vehicle usage
- Vehicle storage conditions

When cars are found to be at low mileage or have not been used regularly for an extended period of time, the oils and compound of the rubber can dry up due to a lack of repeated compression, this can lead to compound separation.

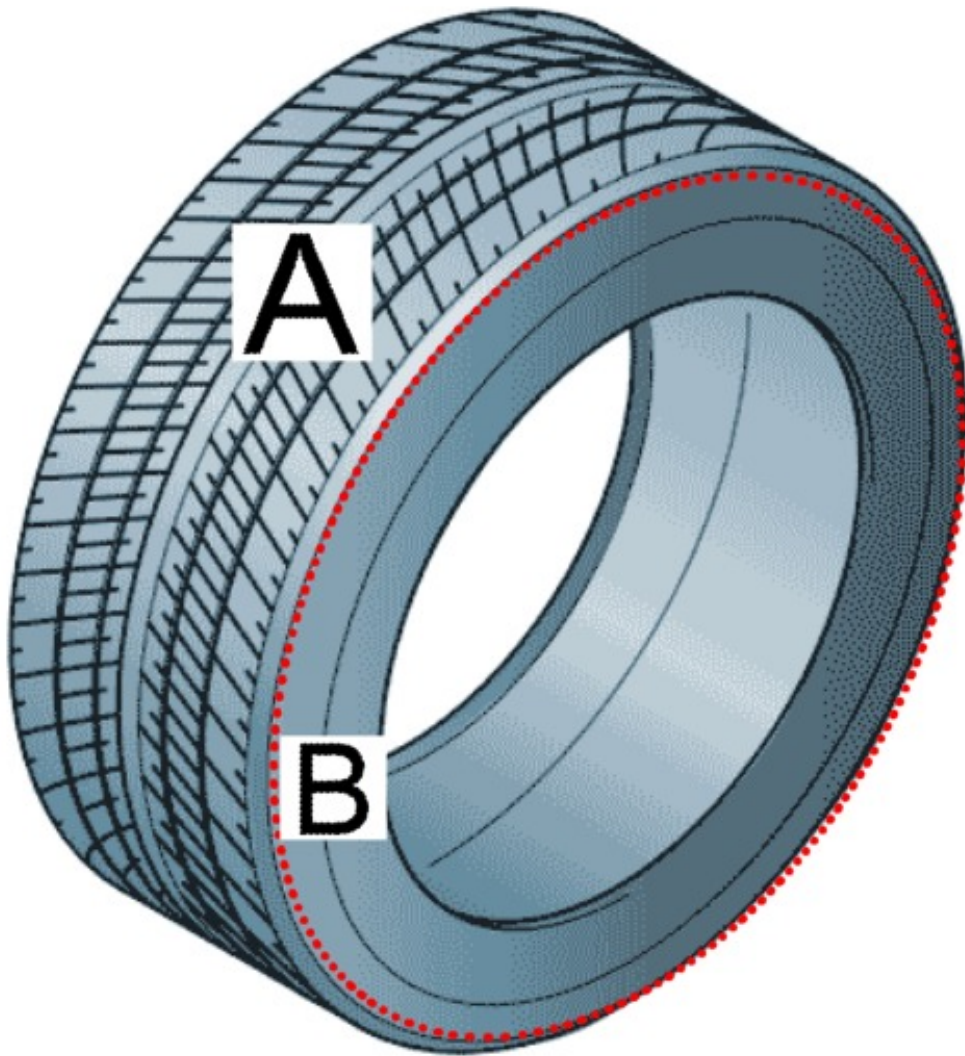
Referring to Figure 3

- Tyres will require replacement if cracks and/or signs of wear are found on or around the tread pattern (Point A)
- In the event that cracks and/or signs of wear are found on the sidewall (Point B) or at (Point A and B) the operative MUST raise a technical DISS query ensuring clear photographs and information detailing customer usage profile are attached to the DISS query
