BULLETIN NUMBER:  
**SB25-K-002**

## **DTC P0711 TRANSMISSION FLUID TEMPERATURE SENSOR CIRCUIT-PERFORMANCE**

- 2024-2026MY Isuzu NQR/NRR 6.6L Gasoline Engine equipped with Allison Transmission.

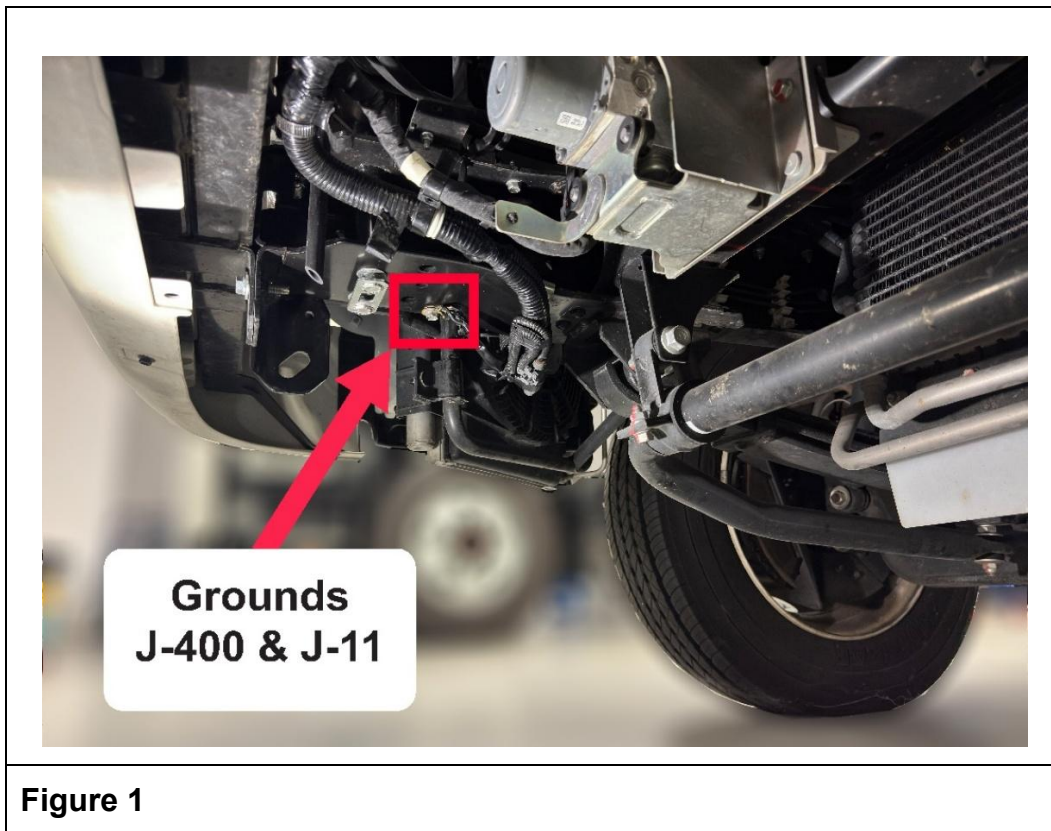
**Figure 1**

Some customers may experience an illuminated Malfunction Indicator Lamp (MIL) and/or Check Transmission Light driven by DTC P0711 Transmission Fluid Temperature Sensor Circuit-Performance. Additionally, a DTC P0700 Transmission Control Module Requested MIL Illumination may be present.

1. Set the parking brake and block the wheels.
2. Turn OFF the ignition.
3. On the bottom of right front frame rail behind the front bumper, locate TCM chassis ground terminals J-400 and J-11. (See Figure 1.)

4. Remove the ground bolt from the frame rail and use a wire brush to clean the bolt, ground terminals, and frame contact areas. Ensure that all bare metal surfaces are completely clean of any corrosion.
5. Reinstall the bolt removed in Step 4 with both grounds. Tighten to the specification below:

<b>Tightening Torque:</b>	<b>26 N•m (19 lb•ft)</b>
---------------------------	--------------------------

6. Ensure connector cavities are clean and dry then apply Dielectric Silicone Lubricant (Part Number 8-12345-579-0) onto the ground terminals and the bolt that are exposed to the outside environment.
7. Connect IDSS to the vehicle and turn the ignition to “ON”. Clear any DTCs.
8. Drive the vehicle under normal operating conditions and confirm that the DTC has not returned.
9. If DTC P0711 returns, refer the customer to a certified Allison repair facility.
