Technical Service Bulletin

Topic	Automatic High Beam does not function (NAR) Bentayga Series 24MY
Market area	United States E05 Bentley USA and rest America (6E05)
Brand	Bentley
Transaction No.	2078841/1
Level	EH
Status	Released for publishing
Release date	Oct 29, 2025

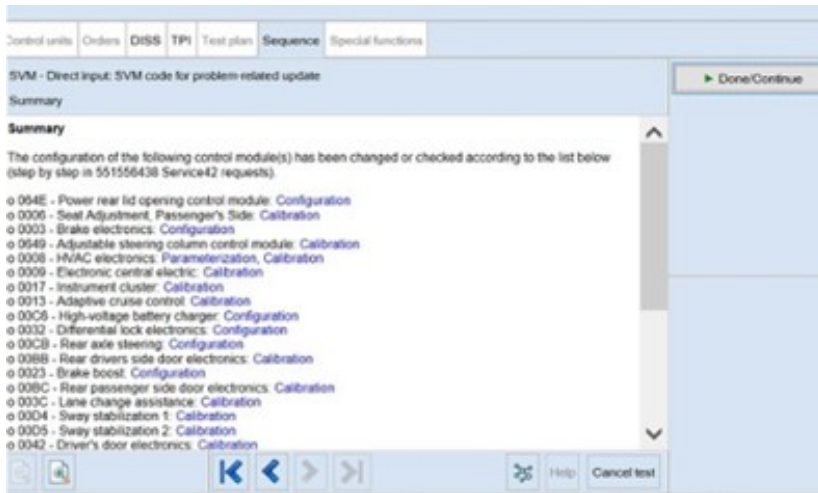
8. If the SVM code completes successfully, ODIS should display as per the image above.
