Technical Service Bulletin

Topic	Creaking From the Rear of the Vehicle - Diagonal Strut Brace Bolt Loose
Market area	Bentley: worldwide (2WBE),China 796 VW Import Comp. Ltd (Vico), Beijing (6796)
Brand	Bentley
Transaction No.	2076757/3
Level	EH
Status	Released for publishing
Release date	Oct 29, 2025

25MY Continental GT & Flying Spur

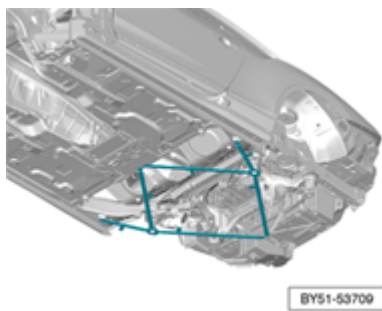
Figure 1

The source of the banging noise is the diagonal strut brace (Figure 1)

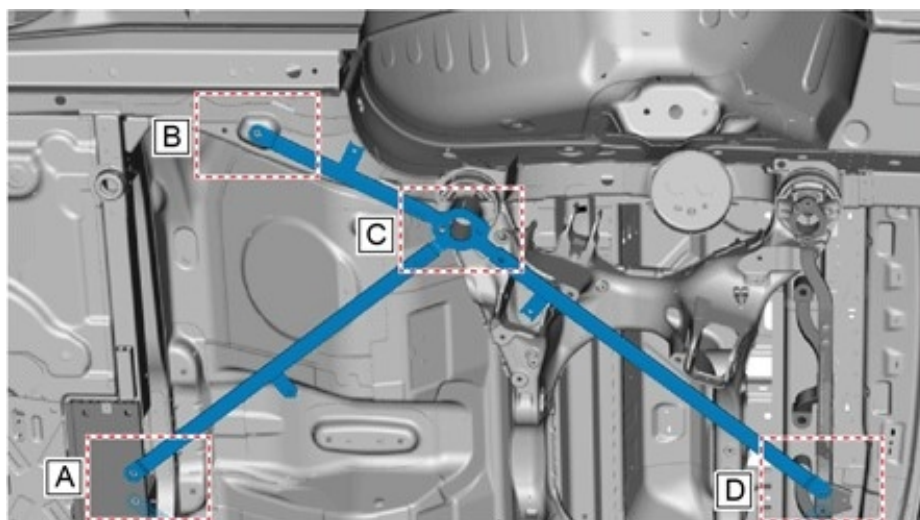
Figure 2

The bolts on either side, highlighted in box B (Figure 2) are coming loose and causing the noises from the diagonal strut brace.

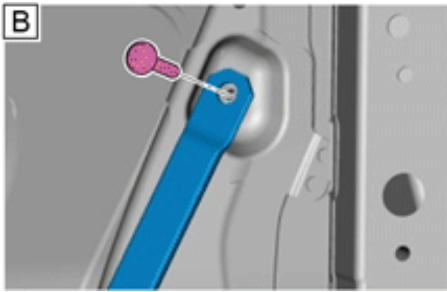
Figure 3

2) If the bolt is not within the specified torque this could be due to contamination. Remove the bolt and replace with the new bolt (see parts information).

1) Check the torque value of bolt "B", highlighted in Figure 3, on BOTH sides of the vehicle. Refer to ElsaPro, Repair group 51 "Diagonal Strut Brace – To remove and fit".

NOTE: Do NOT remove the full diagonal strut brace.

Before replacing the bolt ensure the thread is cleaned to remove any wax.

Ensure the bolts are torque tightened to the specified torque.

New part number for bolt “B” – N.909.210.02
