Technical Service Bulletin

Topic	DTC U110100 evident within address 0084 (Night Vision System) Bentayga Series 24MY
Market area	Bentley: worldwide (2WBE),China 796 VW Import Comp. Ltd (Vico), Beijing (6796)
Brand	Bentley
Transaction No.	2079206/1
Level	EH
Status	Released for publishing
Release date	Oct 29, 2025

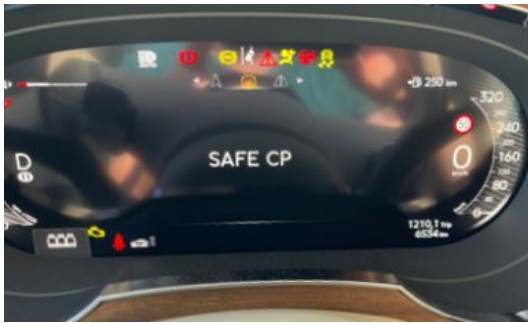
Customer reports that 'SAFE CP' (component protection) is illuminated on the Driver's Instrument Panel.

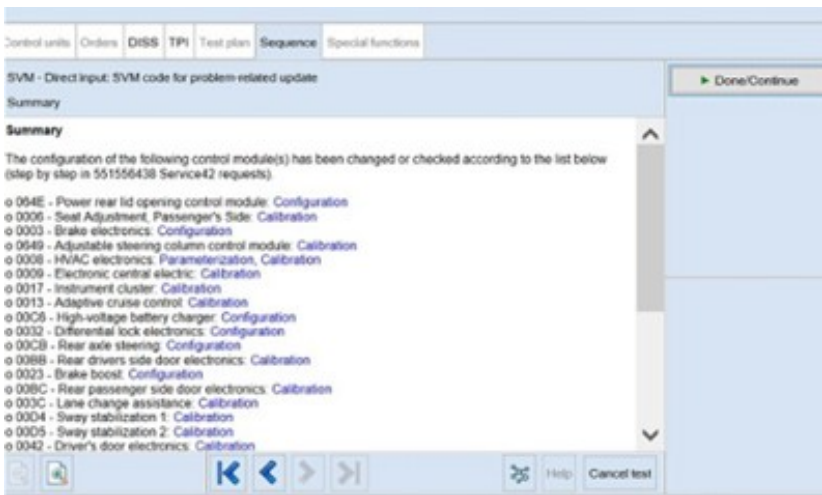
8. If the SVM code completes successfully, ODIS should display as per the image above.
