Topic	Titanium sports exhaust system - Clamp Installation Bentayga 26MY (SC25/44)
Market area	Germany E02 Bentley rest Europe (6E02),United States E05 Bentley USA and rest America (6E05)
Brand	Bentley
Transaction No.	2079821/1
Campaign number	ED72
Note	
Type	
US code

Titanium sports exhaust system - Clamp Installation | Bentayga | 26MY (SC25 /44)

Release date: Oct 29, 2025

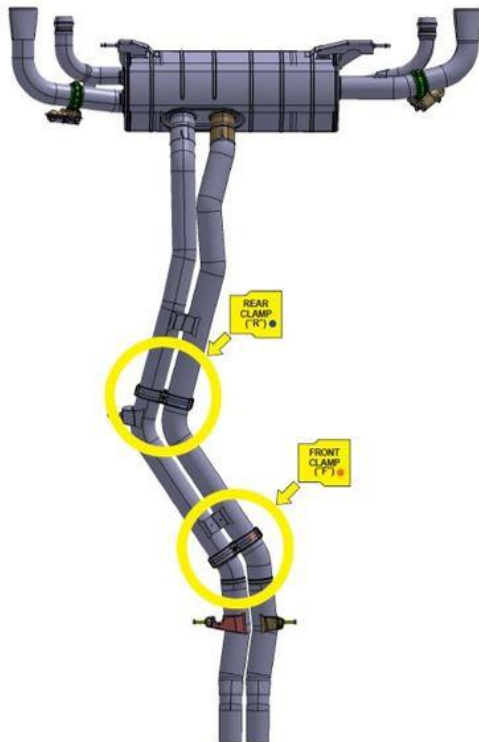
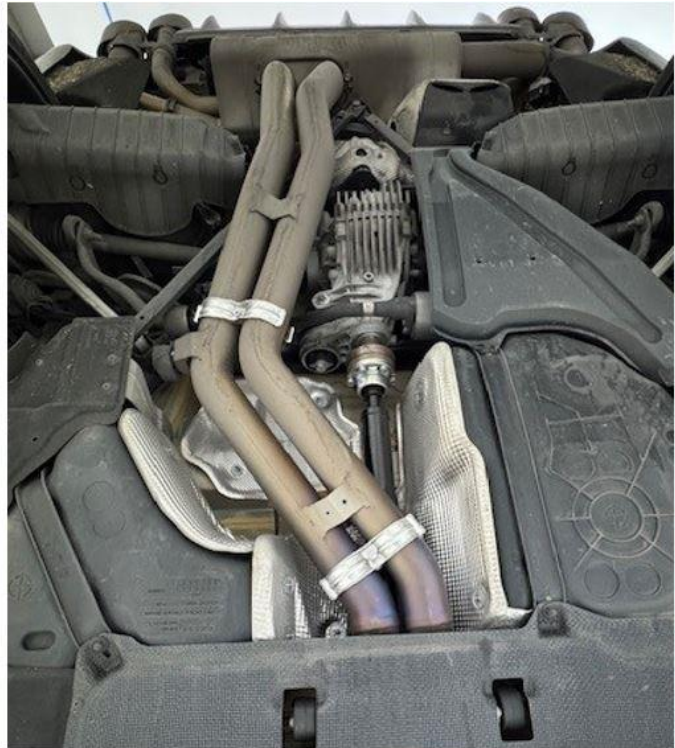
Figure 1. *Bottom View of the exhaust system with clamps installed*

Affected vehicles have been identified for a containment action with regards to the Titanium Sports Exhaust. Through vehicle testing phases, a potential concern has been identified where a customer may experience a rattle in their exhaust system when the vehicle reaches 30,000–40,000 kms. Clamp brackets are required to be installed to mitigate this potential concern.

2. Identify the front and rear clamp positions as per figure 1 diagram.
