# Technical Service Bulletin

<b>Topic</b>	Service info: Leather Damage/Anomalies   All Models
<b>Market area</b>	Bentley: worldwide (2WBE),China 796 VW Import Comp. Ltd (Vico), Beijing (6796)
<b>Brand</b>	Bentley
<b>Transaction No.</b>	2078395/2
<b>Level</b>	EH
<b>Status</b>	Released for publishing
<b>Release date</b>	Oct 29, 2025

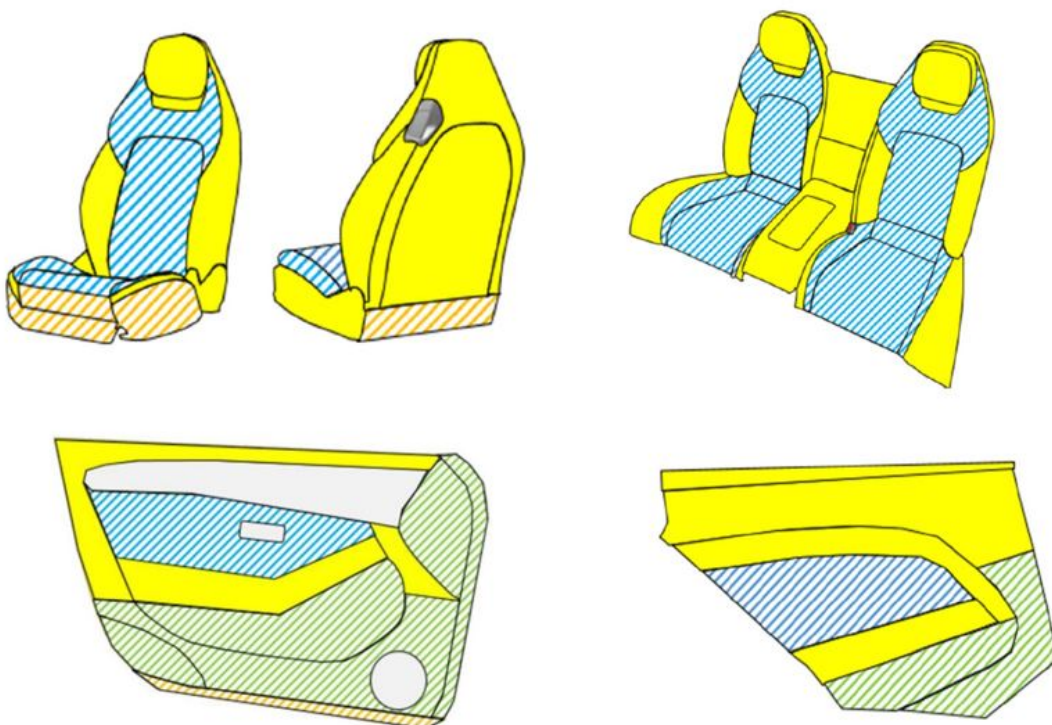
### Continental GT/GTC

Zone A: Direct Visible Area

Zone B: Indirect visible area

Zone C: Indirect Non-Visible Area

Zone A / (Quilted) Zone B
