Mitsubishi Motors North America, Inc.
TECHNICAL SERVICE BULLETIN

**NOISE FROM BRAKE CALIPER WHEN BRAKING
OR CORNERING**

No: TSB-24-35-001

MY 22-24 Outlander

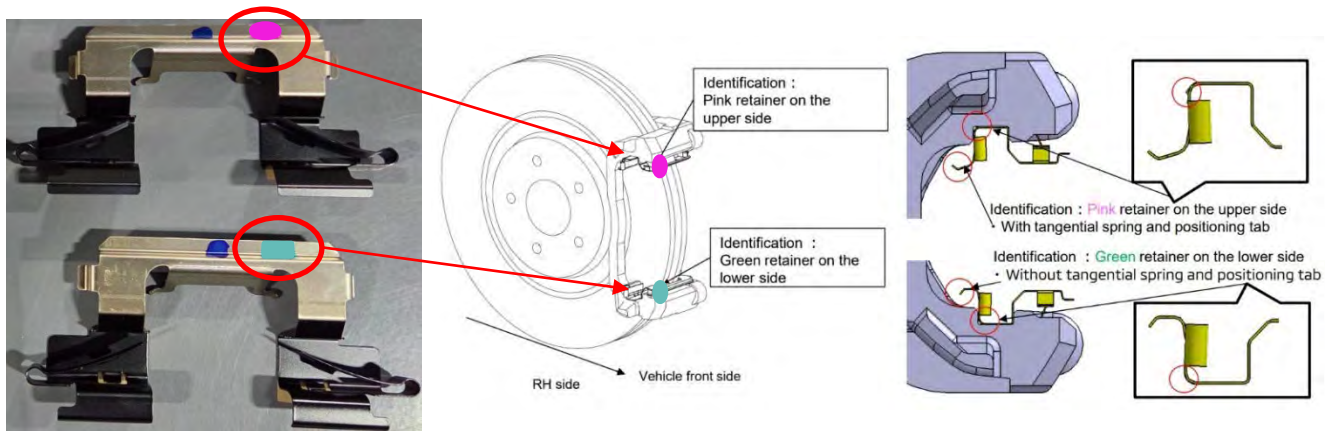
Note: The brake pad retainer shapes differ between the upper (Pink dot) and lower (green dot), refer to the pictures in the parts information section in this document, ensure proper installation.

It is imperative to perform thorough cleaning of brake dust from the brake caliper bracket, as its essential to ensure proper adhesion of the new brake pad retainers to the brake caliper bracket.
