Topic	91 PSS MMI sound: Settings for surround sound via head restraints are missing
Market area	United States 444 Volkswagen of America, Inc. (6444)
Brand	Audi
Transaction No.	2077615/2
Level	EH
Status	Released for publishing
Release date	Oct 7, 2025

This PSS applies to MY 2025 PPE/PPC vehicles A5 (FU), A6 e-tron, Q5 (GU), and Q6 e-tron.

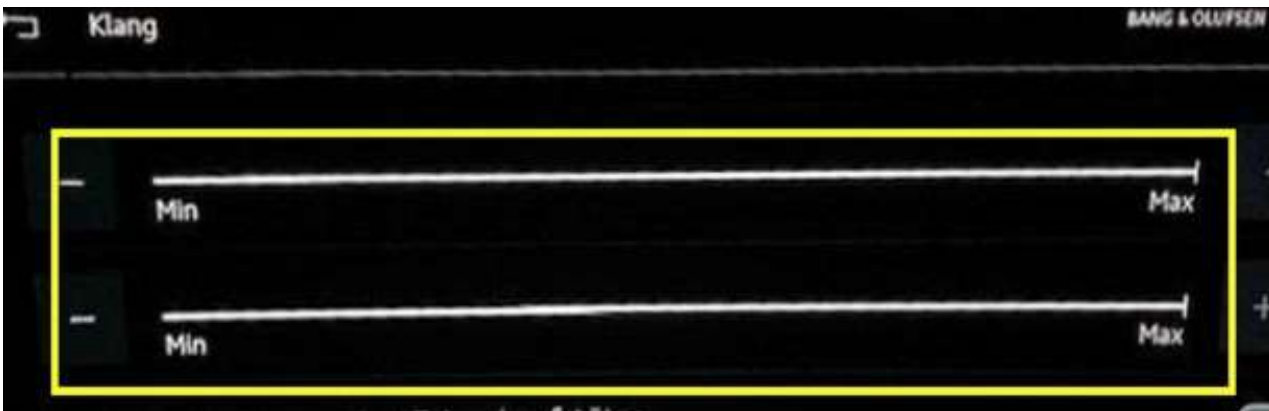
The buttons for surround sound in the driver and passenger head rests are missing in the MMI sound settings; two unmarked bars (Figure 1) are shown instead. Operating these bars does not affect the sound settings.

Figure 1. Two unmarked bars are shown instead of buttons for surround sound in the head rests.

The concern occurs sporadically. The buttons for surround sound may be displayed again after a bus sleep cycle.

Software issue.

1. Explain to the customer that a solution is expected to be available by the end of the 4th quarter of 2025 (subject to change) and that no repairs are necessary at this point.

2. Do not replace any components for this condition since this will not resolve the customer's concern.
3. Create a PSS record in the PSS application through the Pending Service Solutions (PSS) link in AccessAudi (under *Related Links >> Service*).

If the complaint is made, it can possibly be remedied by performing a soft reset (pressing and holding the volume control) or a bus sleep cycle.
