Technical Service Bulletin

Topic	35 Gearbox Malfunction Warning, DTC P0C2900 in the TCM
Market area	United States 444 Volkswagen of America, Inc. (6444)
Brand	Audi
Transaction No.	2050723/8
Level	EH
Status	Released for publishing
Release date	Oct 17, 2025

A3 USA MY17-18 with DQ381, PR Code 0IJ

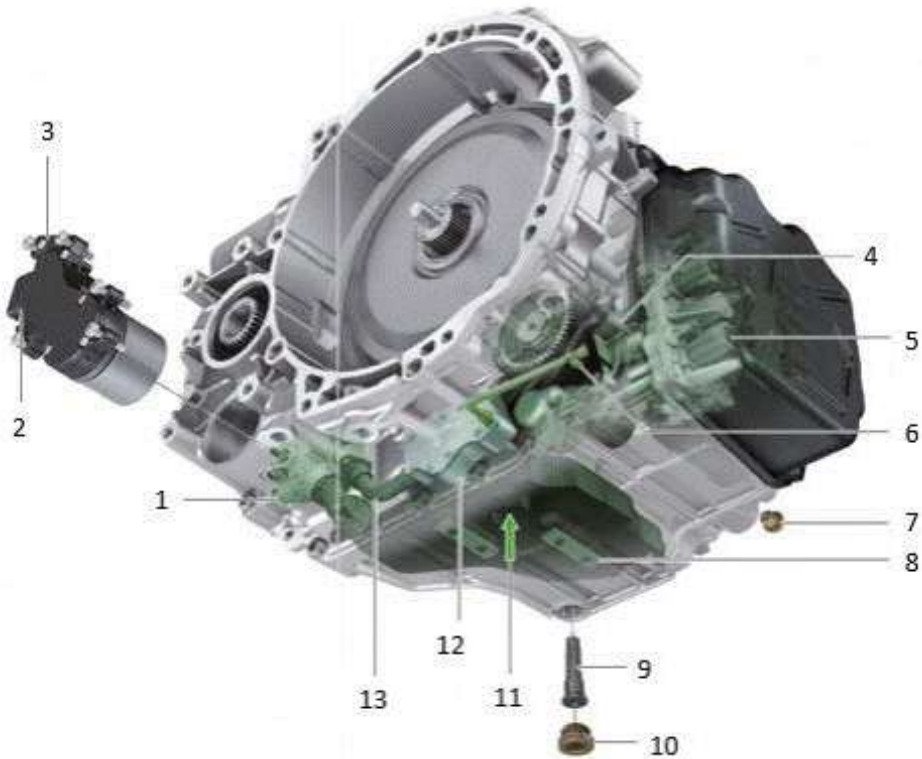
Figure 1. OGC Gearbox Components.

Component related issue of auxiliary hydraulic pump 1 (-V475-) for gear oil (Figure 1, item 1).

- Item 1:** auxiliary hydraulic pump 1 for gearbox oil (V475)
- Item 2:** electrical connection for auxiliary hydraulic pump 1 for gearbox oil (V475)
- Item 3:** electric motor for auxiliary hydraulic pump 1 for gearbox oil (V475)
- Item 4:** main ATF pump

Optimized auxiliary hydraulic pump 1 for gearbox oil (-V475-) introduced to production:

- From transmission production date 09/27/2017 onwards
