## Technical Service Bulletin

<b>Topic</b>	60 A6 Avant: water under front trim
<b>Market area</b>	United States 444 Volkswagen of America, Inc. (6444)
<b>Brand</b>	Audi
<b>Transaction No.</b>	2069594/2
<b>Level</b>	EH
<b>Status</b>	Released for publishing
<b>Release date</b>	Oct 17, 2025

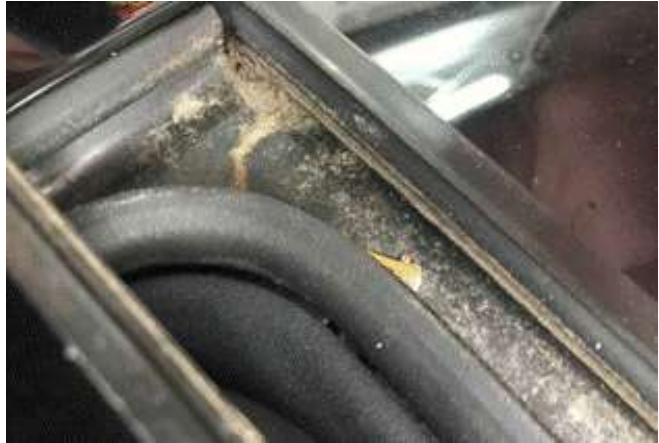
2. Figure 2 shows the dirt in the front sunroof frame with the glass panel opened. Carefully remove all accumulated dirt.

**Figure 2.** Dirt in the front sunroof frame.

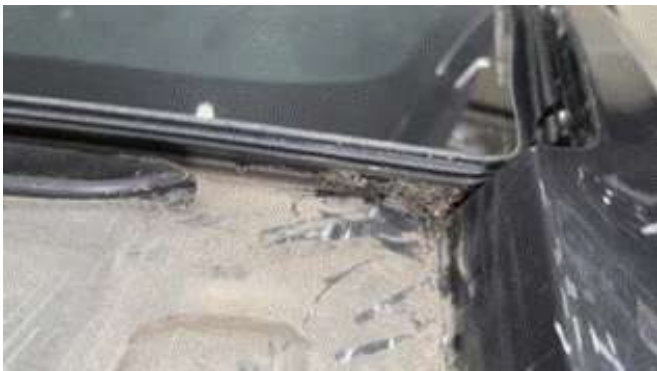
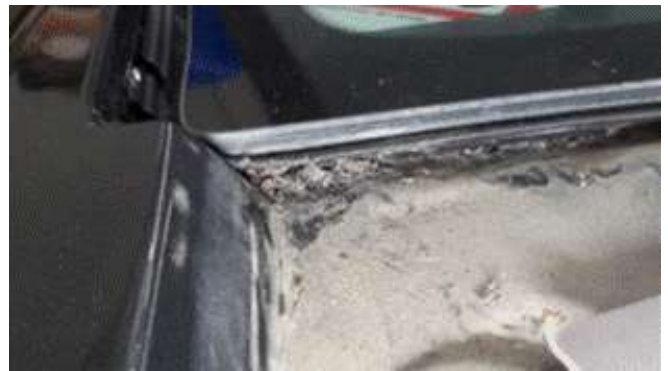
Water is not guided away from the panoramic sunroof via water drain hoses; it drains out of the sunroof frame under the bonded front trim and via the outer A-pillar. The problem here is that fine dirt can block the small water drain channel.

3. Figures 3 and 4 show the actual problem. The water drain channel is blocked by dirt here between the windscreen and the A-pillar. In the photographs, the front trim has been cut out so that this location can be seen.

**Figure 3.** Water drain channel blocked by dirt.

**Figure 4.** Water drain channel blocked by dirt.

4. **Customer service solution:**

Clean the blockage

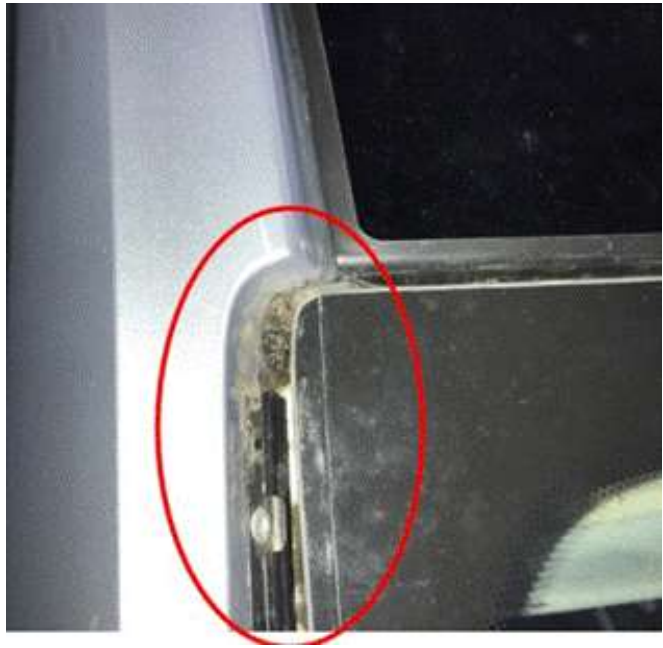
*Figure 7. Dirt in exposed channel.*

6. Now take a pneumatic gun and loosen the dirt. **The pneumatic gun must also be held pointed upwards so that the dirt under the front trim is also loosened.** (Figures 8 and 9).
