Technical Service Bulletin

Topic	00 Combined software update 03.01.00/C (28.11.01) KD1**
Market area	United States 444 Volkswagen of America, Inc. (6444)
Brand	Audi
Transaction No.	2077960/6
Level	EH
Status	Released for publishing
Release date	Oct 21, 2025

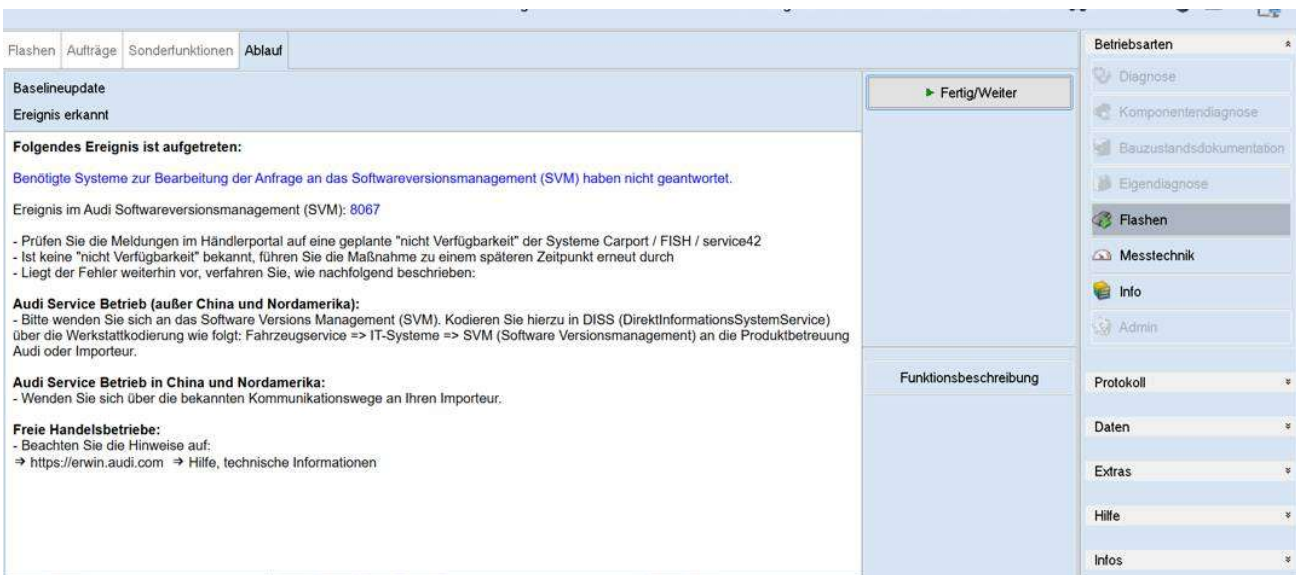
If the ODIS tester cancels the flashing procedure with error code **8067**, this measure does not apply to the vehicle.

Folgendes Ereignis ist aufgetreten:
Benötigte Systeme zur Bearbeitung der Anfrage an das Softwareversionsmanagement (SVM) haben nicht geantwortet.
Ereignis im Audi Softwareversionsmanagement (SVM): 8067

- Prüfen Sie die Meldungen im Händlerportal auf eine geplante "nicht Verfügbarkeit" der Systeme Carport / FISH / service42
- Ist keine "nicht Verfügbarkeit" bekannt, führen Sie die Maßnahme zu einem späteren Zeitpunkt erneut durch
- Liegt der Fehler weiterhin vor, verfahren Sie, wie nachfolgend beschrieben:
