Technical Service Bulletin

Transaction No.: 2079645/1

01-25-06 - Misfire Due To Excess Intake Flashing

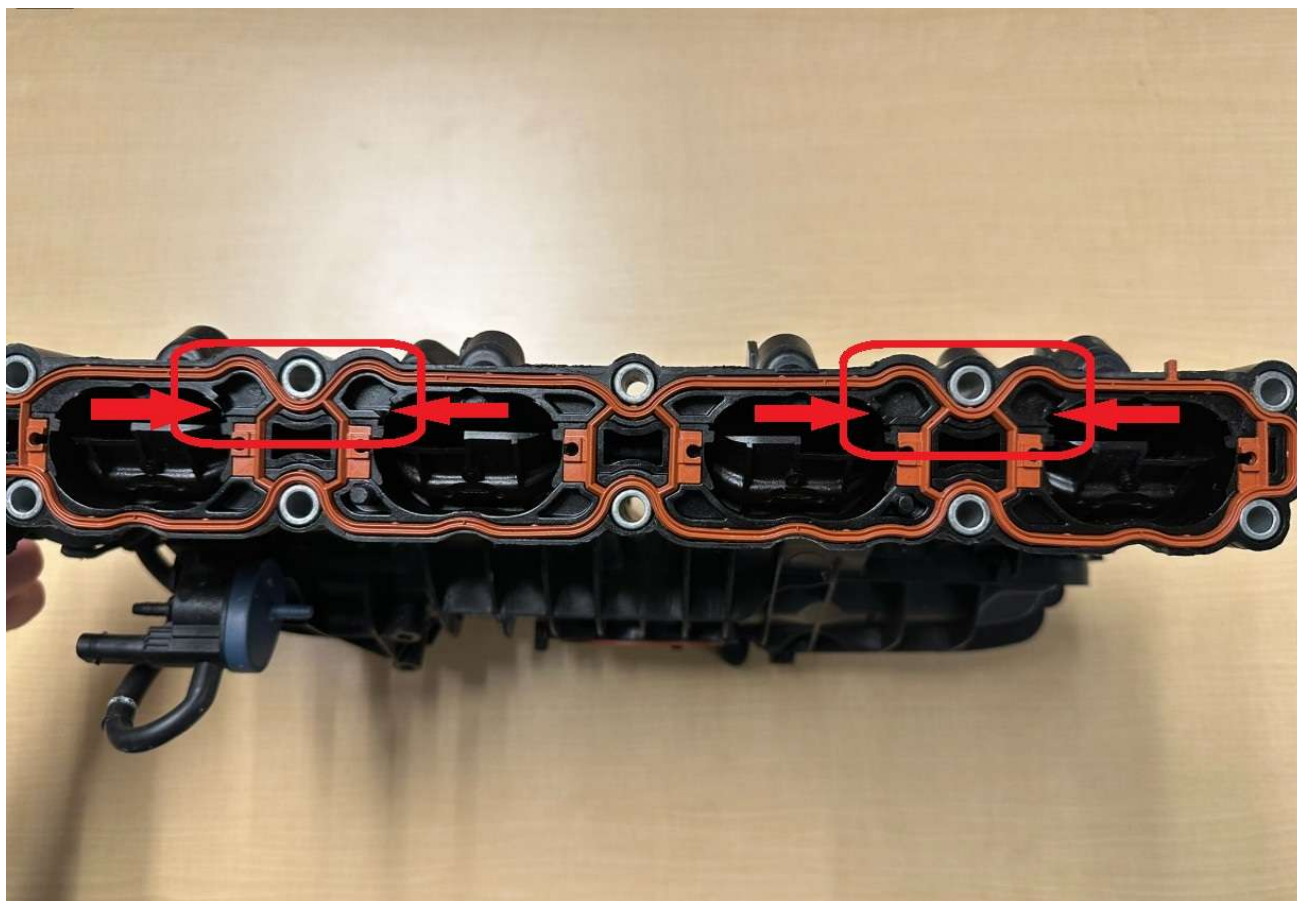
Figure 1:

1. Remove the intake manifold per the steps outlined in the repair manual.
2. Inspect the 4 intake ports for excess flashing in the areas circled in red below in figure 1.

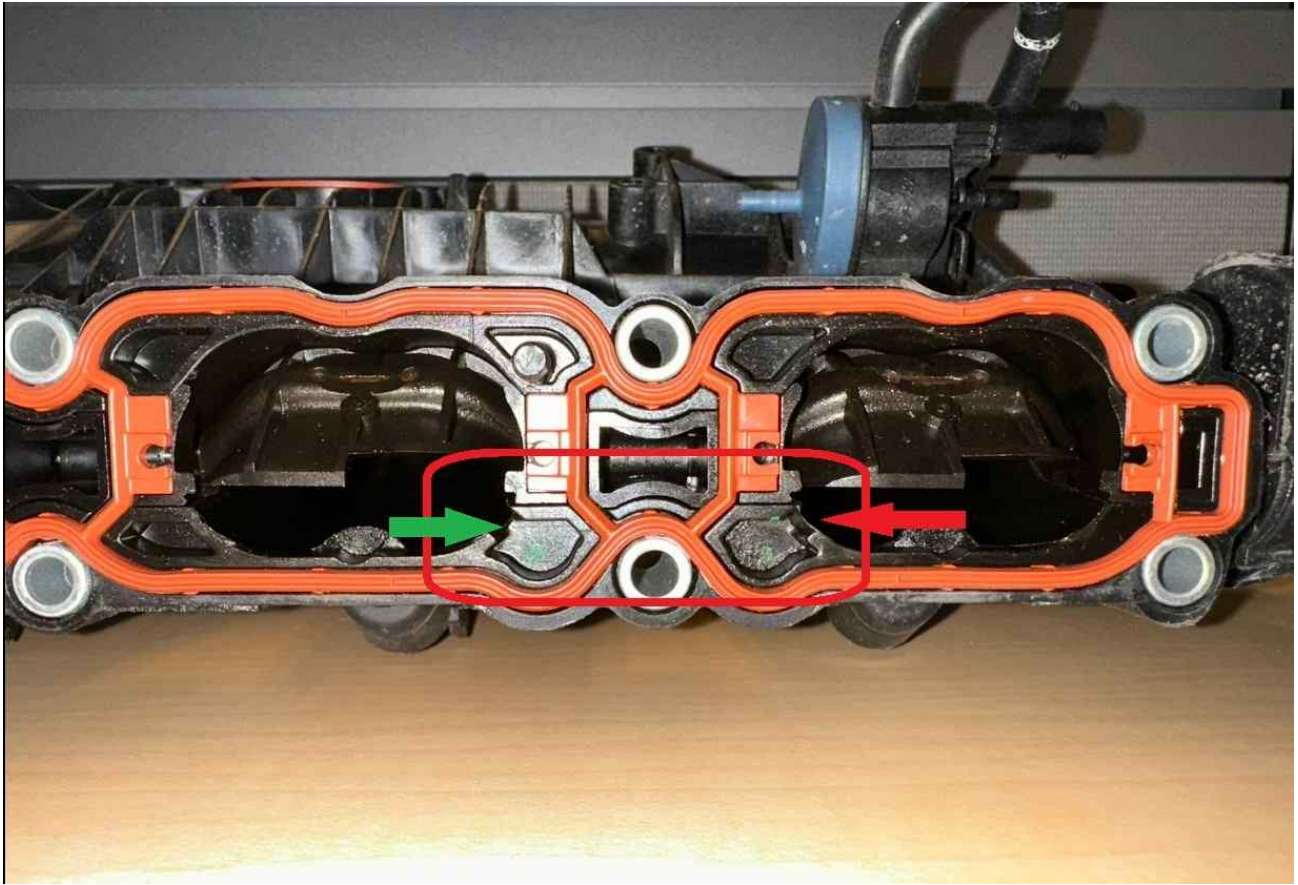
Figure 2:

In figure 2 below, the green arrow shows an intake port without excess flashing, and the red arrow shows an intake port with excess flashing.
