# Service Bulletin

Bulletin No.: PIC6485E

**Subject:** Diagnostic Tip - Noise or Vibration with A/C Compressor on

Brand:	Model:	Model Year:		VIN:		Engine:	Transmission:
		from	to	from	to		
Cadillac	LYRIQ	2023 - 2026		All	All	All	All
Cadillac	OPTIQ	2026		All	All	All	All

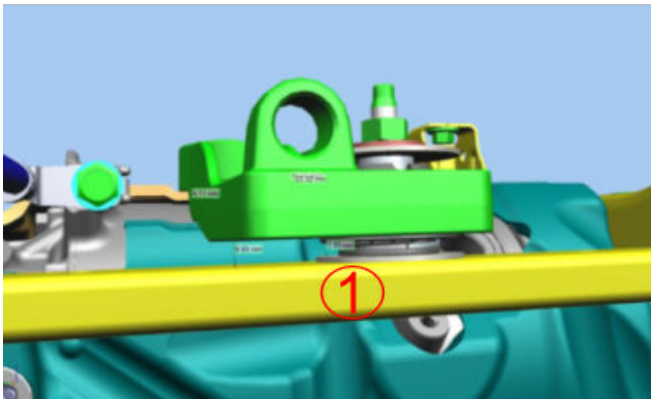
6236078

View from top side front of A/C compressor.

1. Front PEC Rail

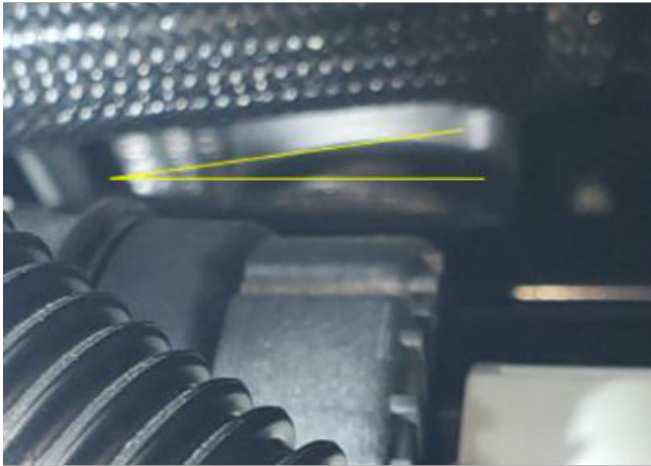
6236079

This is a View from the front of the A/C Compressor/Vehicle. If the gap between the upper Compressor mount to the front PEC rail is not even across the width of the part, then the bracket has twisted when it was installed and can cause NVH issues. If it has twisted, then the gap will be less on the passenger side of the part versus the driver's side.

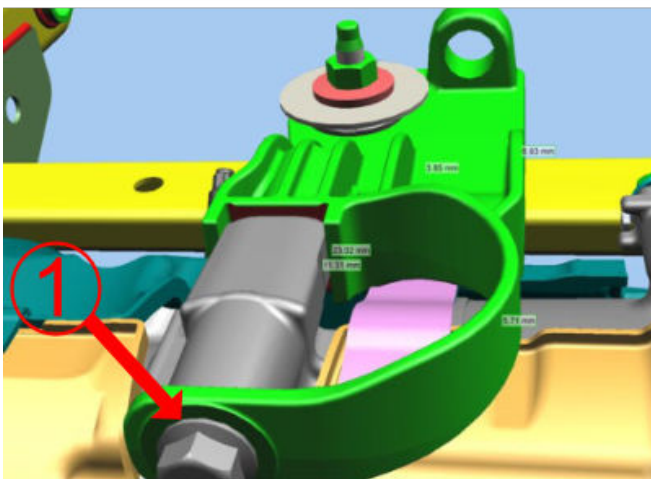
6236080

View from top side rear of A/C Compressor.

1. Loosen the through bolt that secures the compressor to the upper mount bracket enough that the bracket can rotate back to a horizontal position.

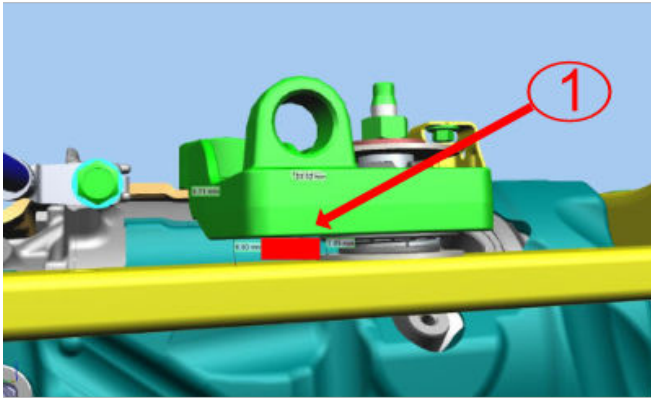
6236081

View from top side front of the A/C Compressor.

Once the bracket is parallel to the ground and the PEC rail again, slide a shim (6.5 mm thick) or a screw driver between the PEC rail and the bottom of the bracket to ensure the bracket does not twist again during re-torquing of the bolt.

Torque through bolt to 30 nm + 45 to 60 degrees.

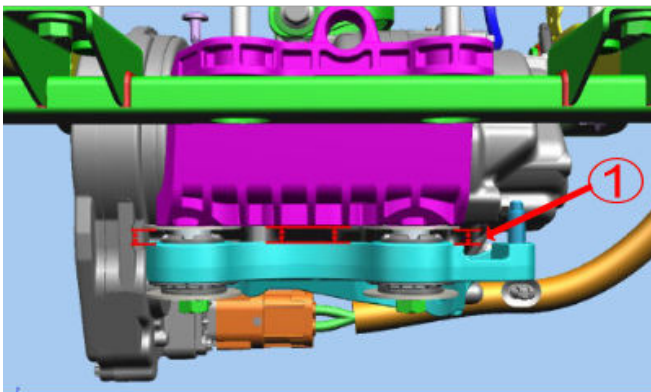
6236084

View from bottom side rear of A/C compressor.

After the fastener from the compressor to top mount bracket has been re-torqued, inspect the condition of the 2 lower mounts. The upper bracket (purple) and the lower bracket (cyan) of the lower mount system should be parallel to each other.

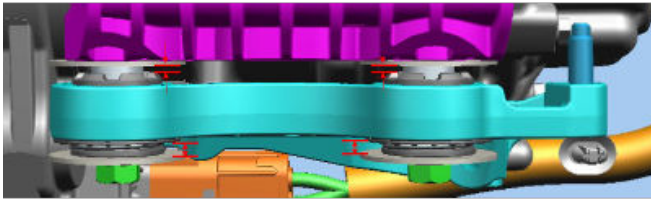
6236086

View from bottom side rear of A/C compressor.

With the compressor in static load position, there should be no contact between the rubber isolator (snubbers) and adjacent metal washers.
