# Service Bulletin

Bulletin No.: PIC6628A

**Subject: Windshield to Dash Valence Foam Seal Mis-positioned**

Brand:	Model:	Model Year:		VIN:		Engine:	Transmission:
		from	to	from	to		
Cadillac	OPTIQ	2025 - 2026		All	All	All	All

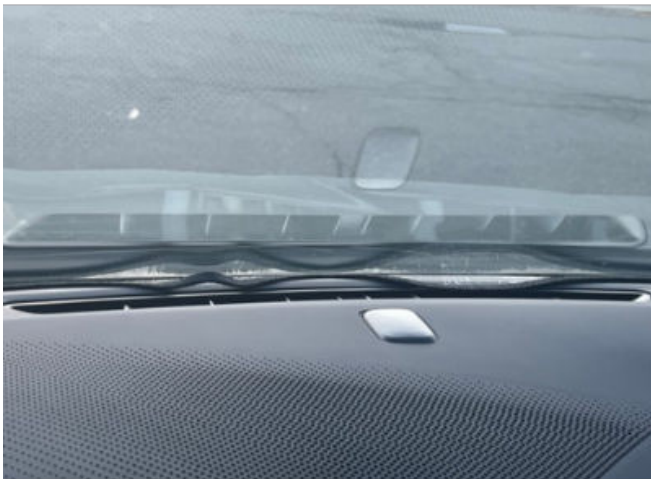
7012512

<b>Involved Region or Country</b>	North America, Canada, Mexico, Europe
<b>Condition</b>	Customers may comment that the foam seal at the base of the windshield, will be visible from either the outside of windshield or from inside the interior when looking at the front of the instrument panel.
<b>Cause</b>	Foam seal adhesive

The foam windshield seal will be visible from either the windshield OR from inside the interior when looking at the front of the instrument panel.

If the reported condition exists, follow the outlined service instructions below.
