Service Bulletin

Bulletin No.: PIT6218C

Subject: SES light P059F

Brand:	Model:	Model Year:		VIN:		Engine:	Transmission:
		from	to	from	to		
Buick	Enclave	2025–2026		All	All	All	All
Chevrolet	Traverse (All New)	2024-2026		All	All	LKO	All
GMC	Acadia	2024-20263		All	All	All	All

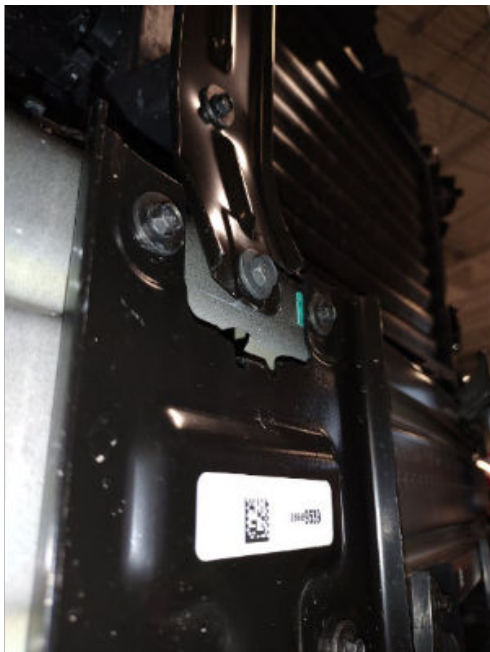
Involved Region or Country	North America
Condition	SES light on with code P059F set for active grill shutter malfunction.
Cause	Possible bent hood support front bumper bracket.

Before replacing the grill shutter inspect the bracket in front of it for being bent as shown below.

If the bracket is bent, remove the bracket and command the shutter with GDS2.

If the shutter will move when commanded replace the bracket only.

If the shutter does not move or does not move smoothly, replace the bracket and shutter.

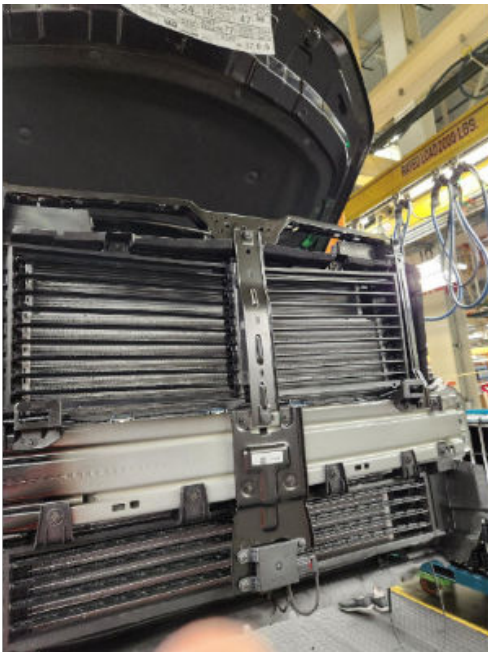
6719671

See the photo below of a good bracket for comparison.
