Complaints about transmission function after replacing the electrohydraulic control unit (EHS valve body) in transmission 725.0 or 725.1

Topic number	LI27.35-P-079971
Version	1
Function group	27.35 - Valve body
Date	11/10/25
Validity	NAG3C 725.0 and NAG3M 725.1 Transmissions
Reason for change	Additional documentation for correct repair procedure

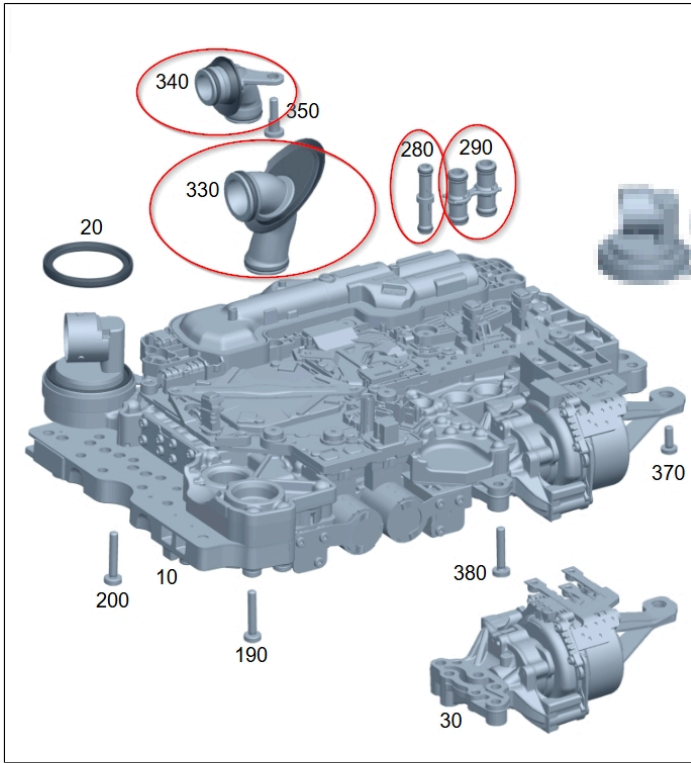
Attachments	
File	Description
EHS_725.0.jpg	280, 290, 330, 340

Missing, incorrectly installed, or damaged guide tubes on the EHS valve body.

NAG3C 725.0 (Non AMG): Part numbers 280, 290, 330, 340

Check for the correct installation of the guide tubes (refer to attachments under "Cause"), correct installation if necessary.

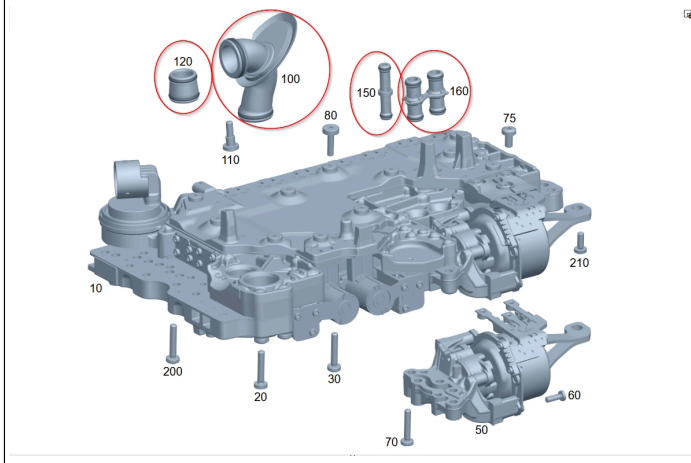
NAG3M 725.1 AND NAG3C 725.0 (AMG only): Part numbers 100, 120, 150, 160
