## AC charging does not function. Charging interrupts after 15 minutes of charging

Topic number	LI47.70-P-079963
Version	1
Function group	47.70 - Powertrain energy supply
Date	11/11/25
Validity	Mercedes-AMG GLE 53 Hybrid 4MATIC+ with SA code ME10
Reason for change

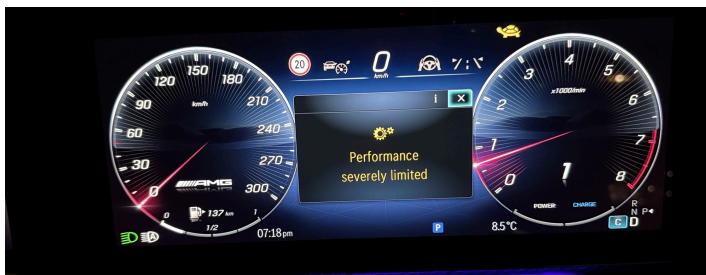
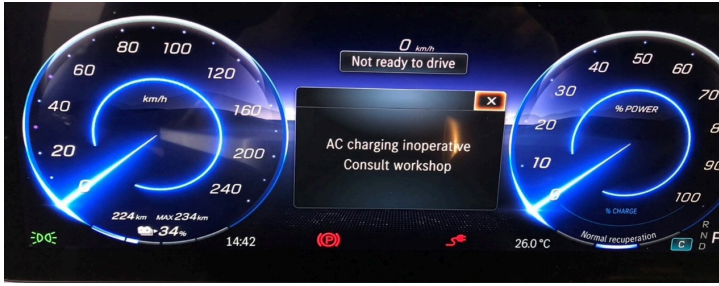
Instrument cluster warning messages :

- "AC charging inoperative Consult workshop"
- "Performance severely limited "Hybrid drive system"

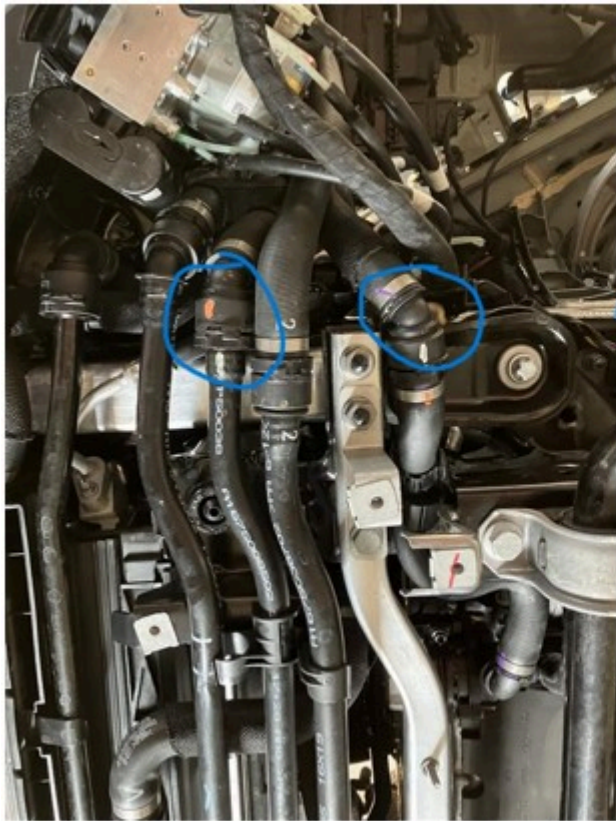
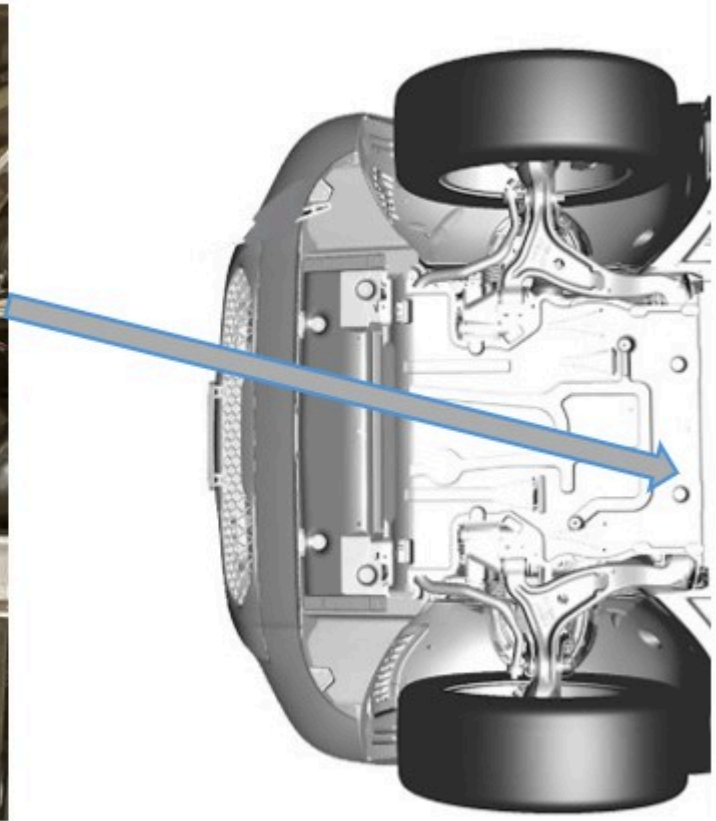
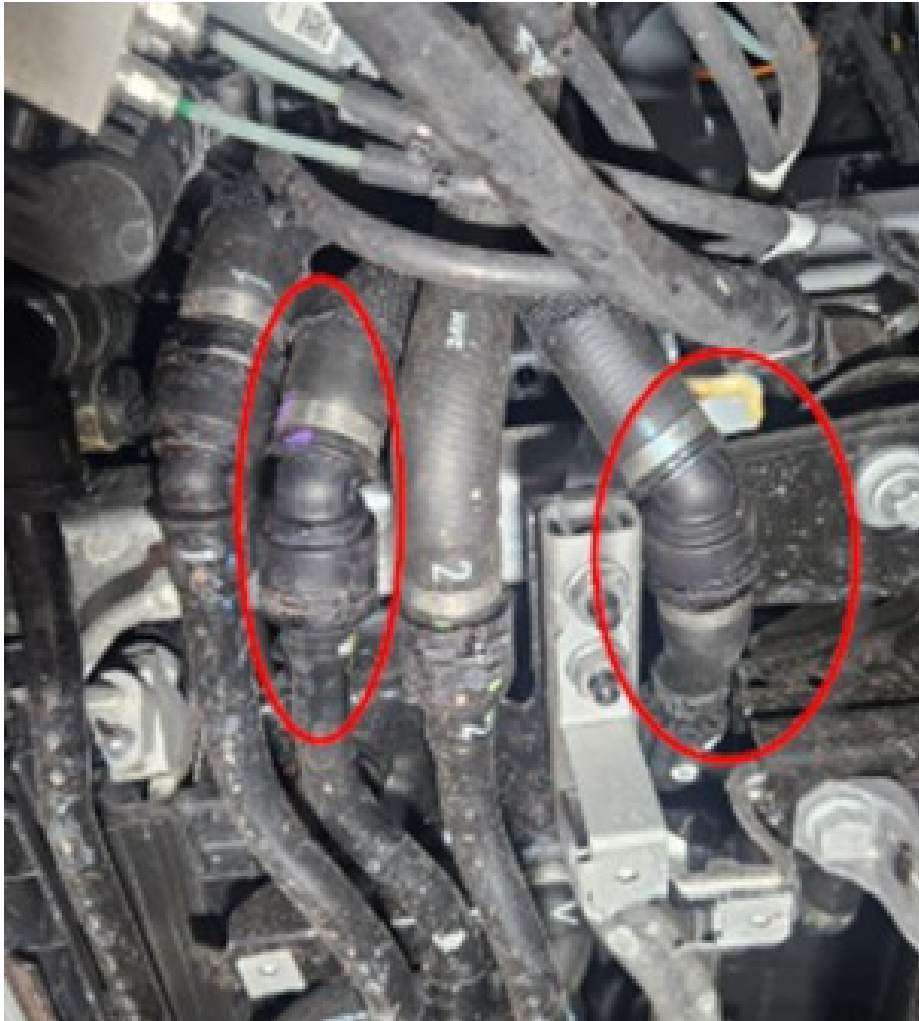
- The coolant lines of the LT1 (low temperature) cooling circuit for the power electronics (N147) and the LT2 (low temperature) cooling circuit for the AC charger (OBL), may have been installed in reverse order

- It is possible that the coolant hoses highlighted in the pictures are installed in reverse order.
- Interchange these two coolant lines and check if the vehicle is charging without any malfunction.

- Do not replace component OBL (N83/11).
