254 206 214 236 with M254 and 725.1 Harsh 2to1 downshifts with ECO Start/Stop OFF

Topic number	LI27.60-P-079969
Version	1
Function group	27.60 - Gearshift, control
Date	11/4/25
Validity	BR254, 206, 214, 236 with Engine M254 and Transmission 725.1 with ISG48V2
Reason for change

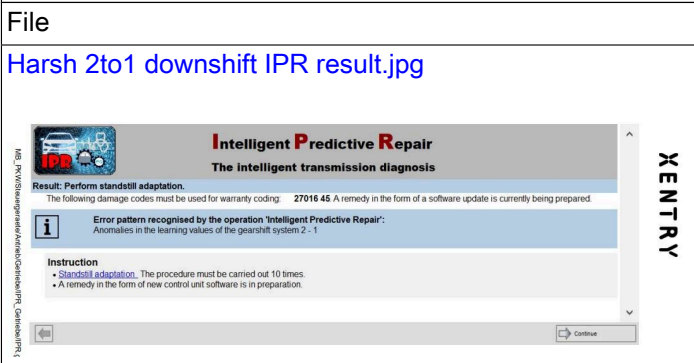
Attachments	
File	Description
Harsh 2to1 downshift IPR result.jpg

Harsh 2-1 downshifts when coming to a stop with ECO start-stop function turned OFF.

Software application when engine is running.

Perform IPR and follow the instruction to perform standstill adaptations.
