Vehicle does not start due to interlock failure

Topic number	LI54.10-P-080004
Version	1
Function group	54.10 - Battery, power supply, voltage converter
Date	11/11/25
Validity	243 with SA codes BAD or BAE
Reason for change

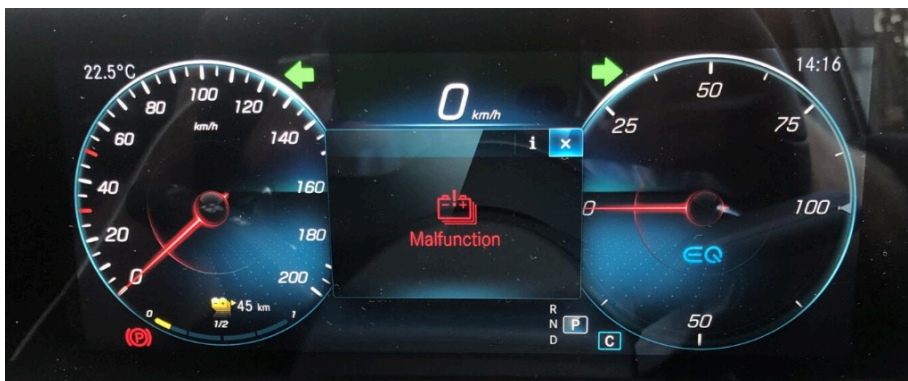
Instrument cluster warning messages :

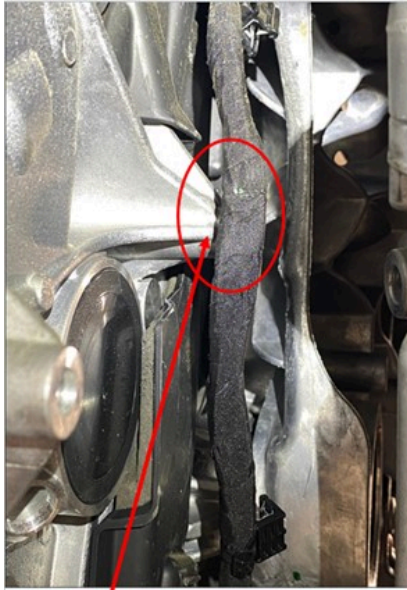
Wiring harness chafed with body near rear e-ATS

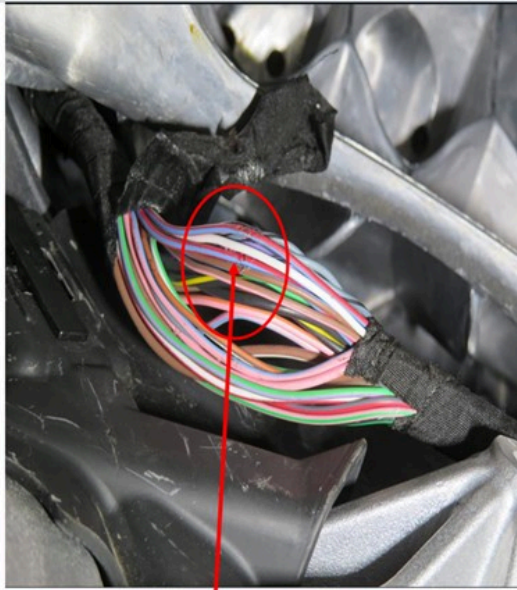
Wiring harness cut near rear e-ATS

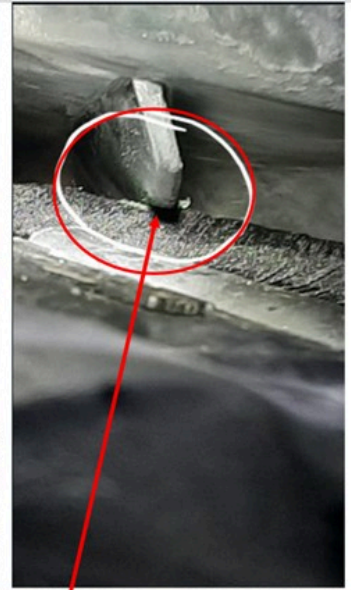
Wiring harness chafed with the body near AC compressor

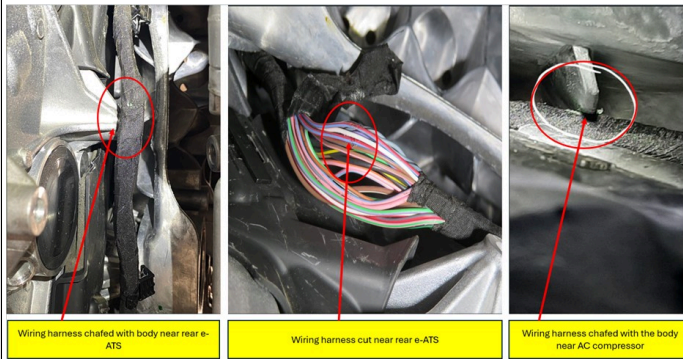
Additional check point 2.jpg

Wiring harness chafed with body near rear e-ATS

Wiring harness cut near rear e-ATS

Wiring harness chafed with the body near AC compressor

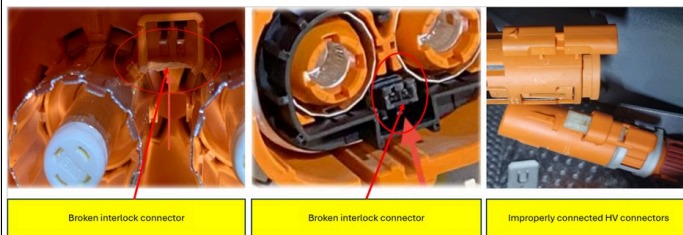
Additional check point 3.jpg

Broken interlock connector

Improperly connected HV connectors

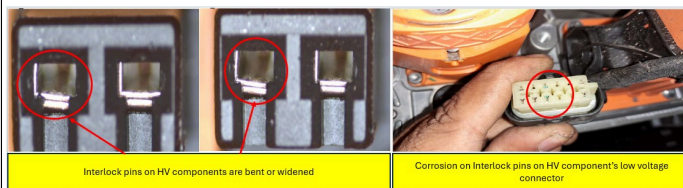
Additional check point 4.jpeg

Interlock pins on HV components are bent or widened

Corrosion on Interlock pins on HV component's low voltage connector
