# Keystone RV Company

## SERVICE ADVISORY # 25-473

### Sun Deck Balcony Hardware

# ADDING SPRING ASSIST/REPLACING HARD STOP LINKAGE ARMS ON THE SUN DECK BALCONY

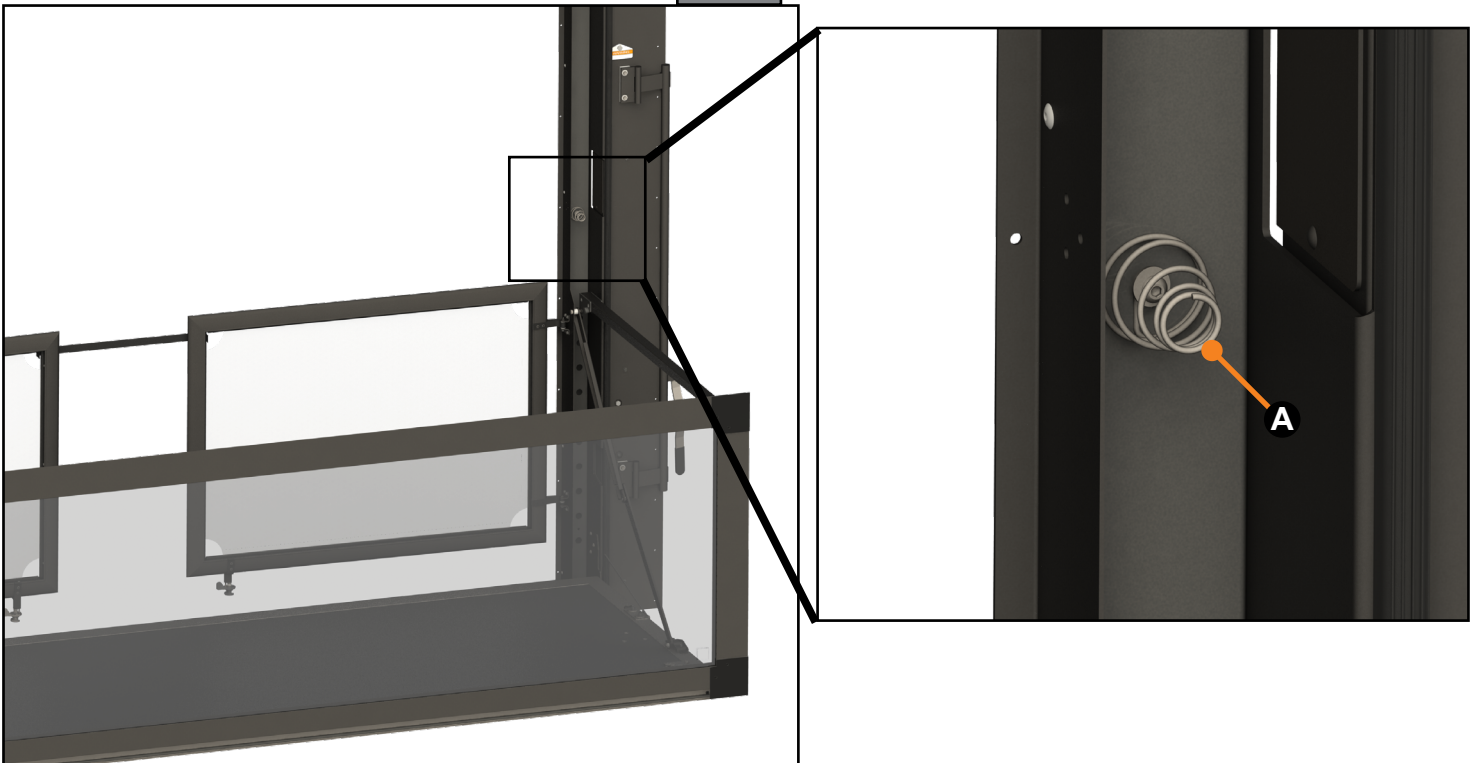
Fig. 1

- Examine each side of the balcony jamb 9 1/2" up from the support arms. Verify that a spring (Fig. 1A) is installed on each side of the balcony at this location. If no springs are present, perform the procedure in the "Adding Spring Assist" section of this TSB.

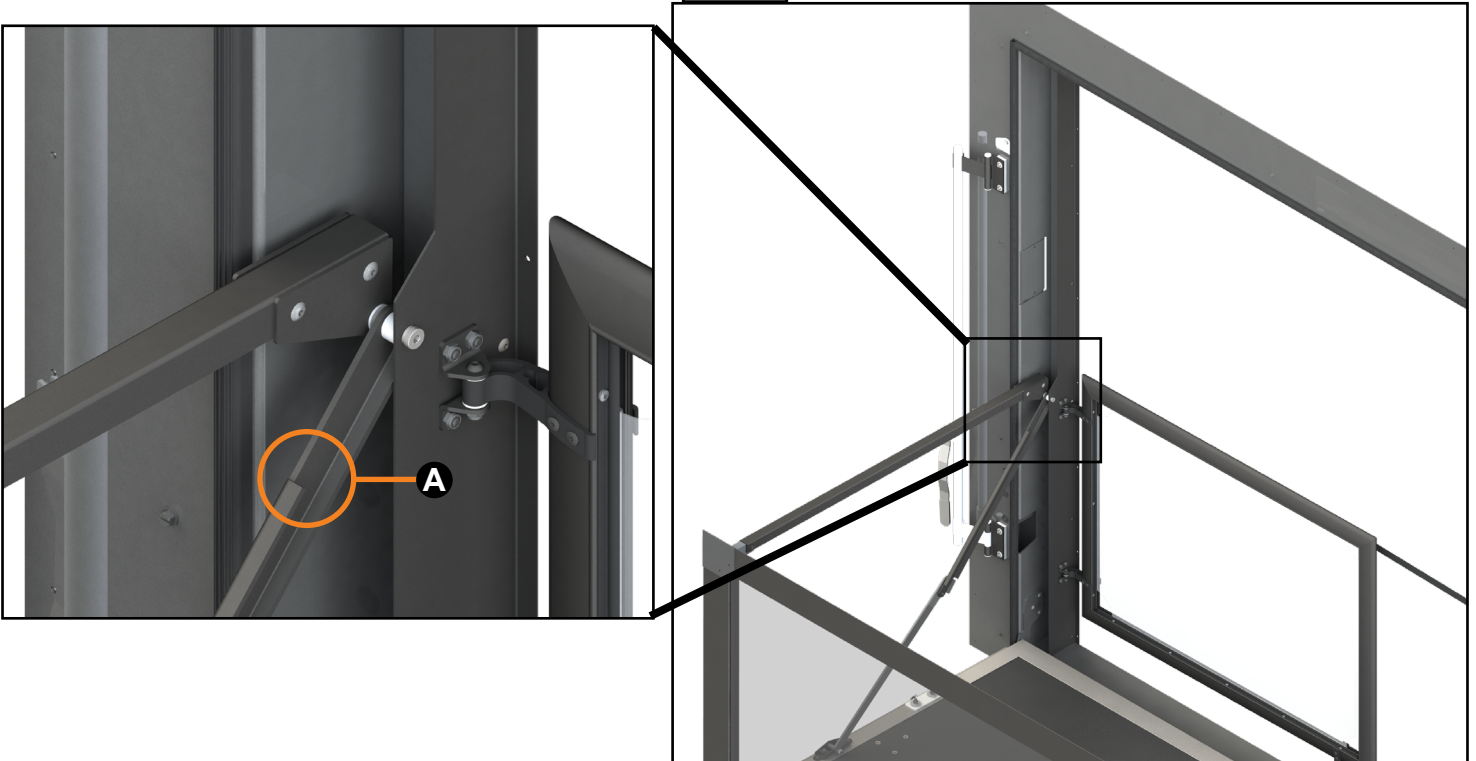
Fig. 2

1. Check the hard stop linkage arms at the location indicated in Figure 2A. Look for a notch machined in the top linkage arm (Fig. 3A). If this notch is **not** present, perform the procedure in the "Replacing the Hard Stop Linkage Arms" section of this TSB.
