Service Bulletin

Bulletin No.: 23-NA-107

Subject: Roof Related Water Leak, Shifter Light Inoperative, Key Fob Inoperative and/or Various Remote Control Door Lock Receiver (RCDLR) Concerns

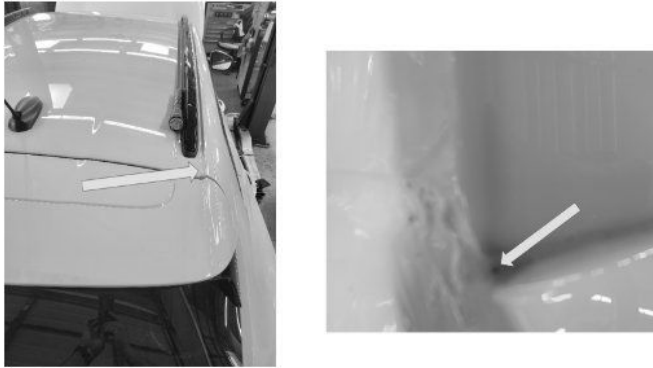
Involved Region or Country	North America
Condition	Some customers may comment on a water leak within the vehicle, shifter light inoperative, key fobs inoperative, and/or various concerns related to the Remote Control Door Lock Receiver (RCDLR).
Cause

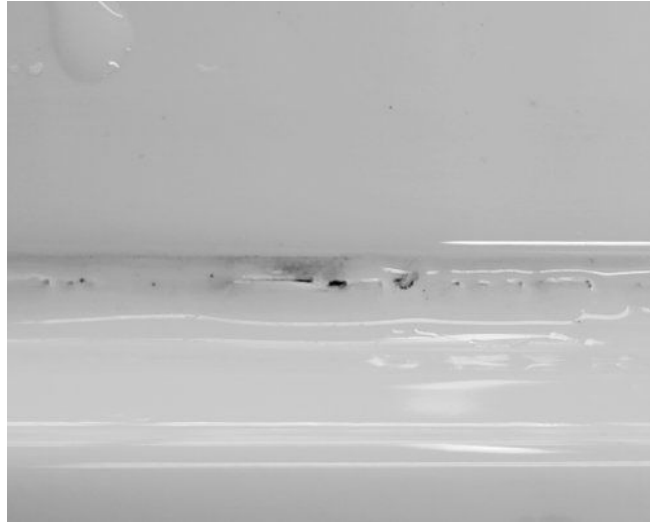
6370899

The cause of the condition may be a pin hole / poor sealing in the roof body seam or poor brazing weld. This condition could occur at either the front and/or rear, and on the right and/or left side or cross rail front stud not sealing to body of the vehicle. ⁶⁵⁰¹²⁵³

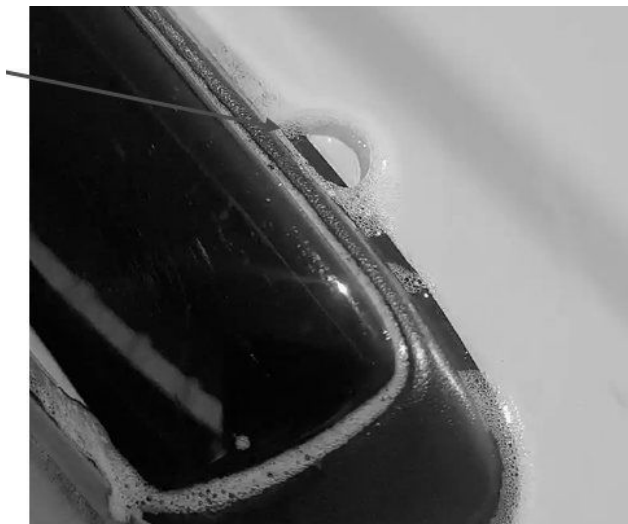
6445101

1. Visually inspect the front right and left roof laser braze, then the rear right and left roof laser braze, for pin holes or a crack.

2. Seal the holes/crack in any laser braze area following the steps below:

- 2.1. Mix a small amount of Kent® High-Tech Seam Sealer Clear P10200, or Wurth Euroseal Gel Clear 18920104, or equivalent WITH the proper touch-up paint color.

- 2.2. Avoiding excess sealer build-up within the ditch, work a small amount of the sealer into the hole with a gloved finger.
- 2.3. Wipe away any excess sealer with a light amount of solvent on a rag or paper towel. The solvent will help the sealer flow into the hole/crack.
