# Service Bulletin

Bulletin No.: 22-NA-007

**Subject: Poor Engine Performance in Extremely Cold Weather Conditions for LE2 Engines, Charge Air Cooler (CAC) Icing - Malfunction Indicator Lamp (MIL) Illuminated, DTC P0299, P0234, P0236, P2227, and/or P00C7 Set**

Brand:	Model:	Model Year:		VIN:		Engine:	Transmission:
		from	to	from	to		
Chevrolet	Cruze	2016	2019	—	—	1.4L Turbo (LE2)	—

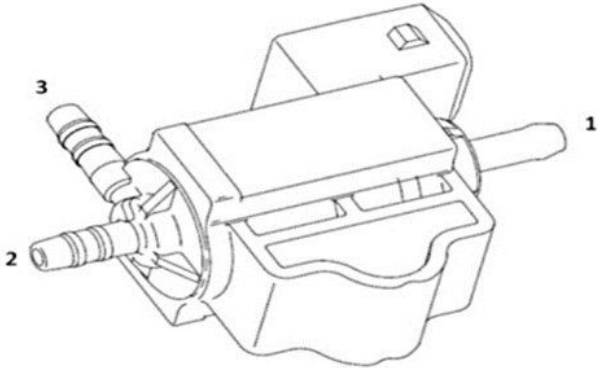
6055068

**Note:** Check port #2 to assure the spring gets lifted off the seat. This will be determined by the compressed air not dead heading when applied to port #2. When applying air to this port a small amount of air should be observed at port #3 and even less air will be noticed at port #1. If this does not happen, the TCV plunger may have hardened deposits from hot operating conditions which will impede TCV plunger movement, and the turbocharger wastegate regulator solenoid valve should be replaced.

3. Using clean shop air regulated to 80-100 PSI, blow through all three ports (1, 2 & 3) for 5 seconds each.

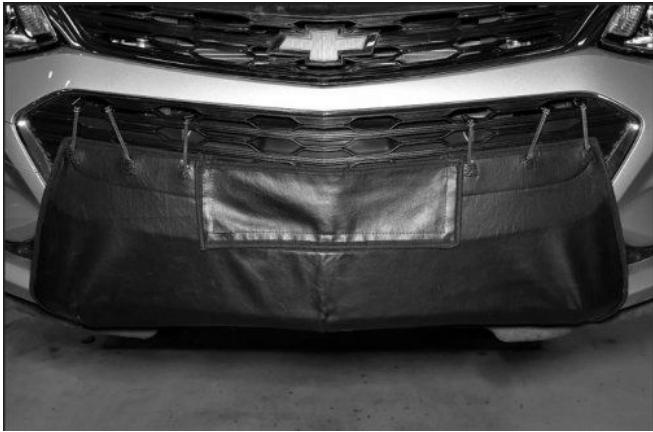
5946388

***Warning: Remove grille cover during temperatures above 32°F/ 0°C to prevent engine and transmission overheating. Remove grille cover before towing a trailer of any size. Failure to do so will decrease transmission cooling efficiency and possibly cause damage to the drivetrain.***

Install the service winter grille cover around the front bumper to prevent ice-build in the CAC. The installation instructions will be provided with the service part.
