Service Bulletin

Bulletin No.: 24-NA-227

Subject: Vibration Rattle or Boom at 1800 to 2000 RPM

Brand:	Model:	Model Year:		VIN:		Engine:	Transmission:
		from	to	from	to		
Chevrolet	Equinox	2025	2026	—	—	—	—
GMC	Terrain	2025	2026	—	—	—	—

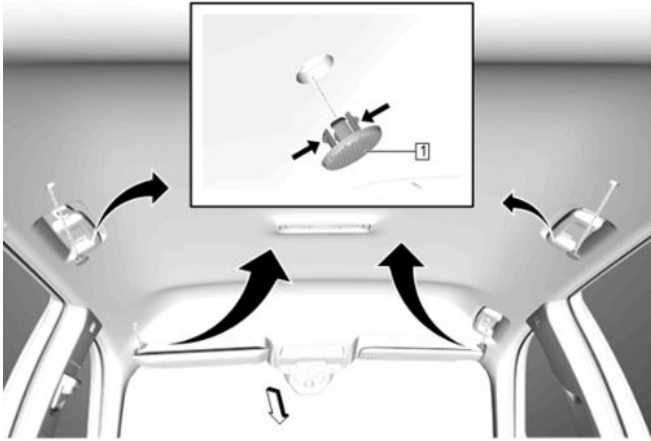
7004221

1. With the car in Drive and the brakes firmly applied, raise the engine RPM to the range the customer hears it in. Once the vibration is active, maintain the RPM and crack open the driver's door. This will disable the ANC system. If the vibration went away, continue to step 1.1. If the vibration remains, continue to step 2, Calibration Update.

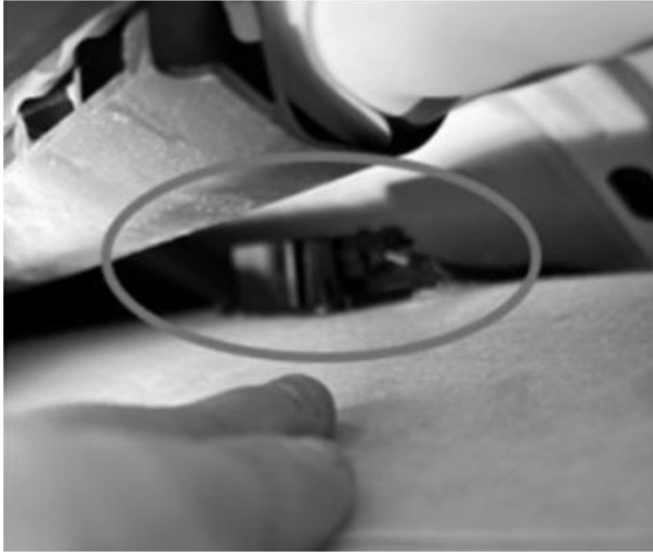
7004223

Example of properly located ANC microphone, shown below:
