# Service Bulletin

Bulletin No.: 25-NA-061  
Date: October, 2025

**Subject: Driver or Passenger Rear Door Handle Will Not Fold In**

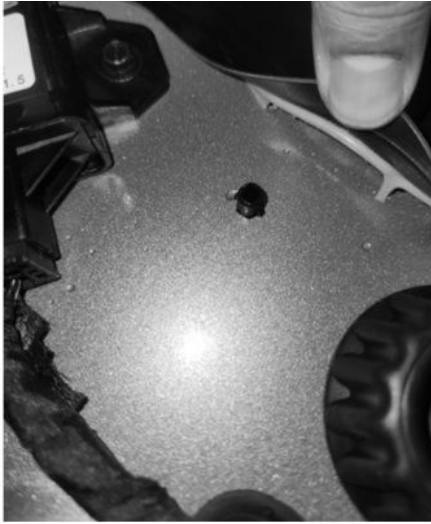
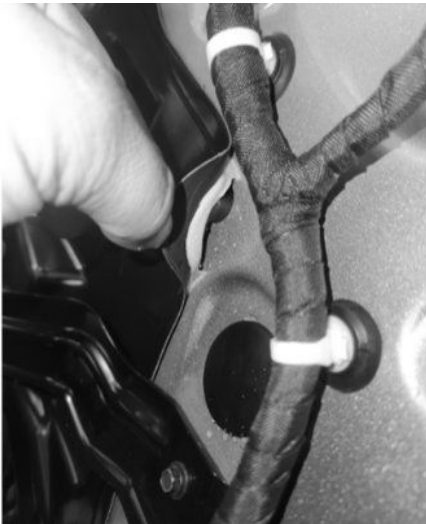
- Depending on which side has the concern, remove the rear driver or passenger side interior door trim panel, refer to SI Doc ID 6367600. Upon inspection, the door water deflector adhesive may not be applied properly, see photos below. A gap may exist between the seal and the door metal where the water intrusion can occur. Please locate where leak is occurring first and re-seal using an appropriate body sealer or adhesive. The water deflector may then be pressed on by hand or rolled on using a hand roller.

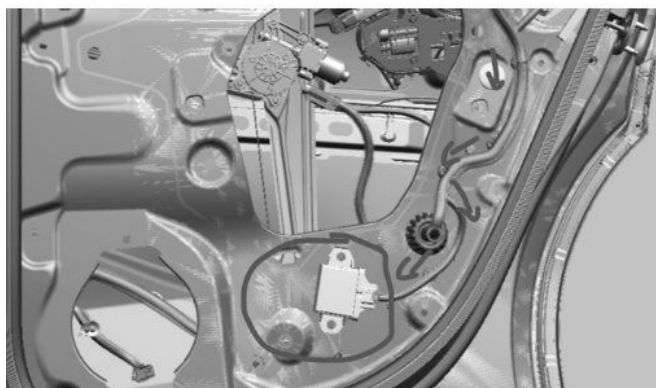
6862951

2. Please also check the door harness wiring and connectors for corrosion, the area of concern would be the J801 Rear Side Door Wiring Harness at or near the Rear Side Door Handle Control Module. The photo below shows where the module is located, and the arrows point toward where the water may be traveling toward the Rear Side Door Handle Control Module.

3. Depending on the amount of corrosion and where located, replace the wiring harness and/or door handle module as needed.
