Service Bulletin

Bulletin No.: 25-NA-152

Subject: Vehicle Leaning to the Side, Vehicle Not Sitting Level - DTC's C118B, C118C, C118E and/or C118F Set

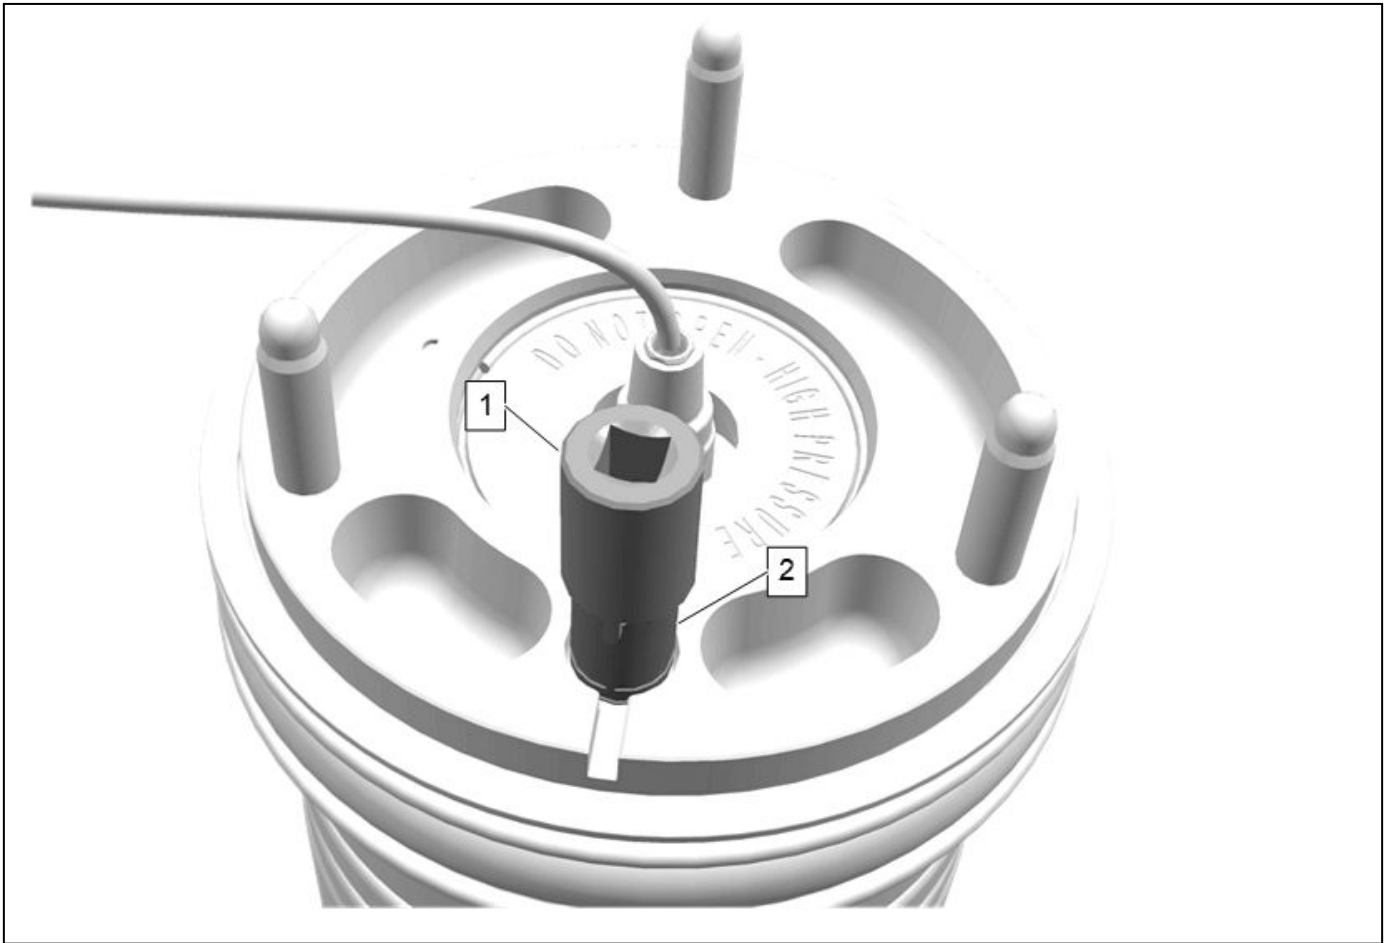
6751412

Note: This valve will require special tool CH-53107 (1), Air Spring Valve Socket for removal.

1. If a customer vehicle exhibits these symptoms and all air lines are verified secured, check the air spring valve (2) on the shock(s) for signs of an air leak.
2. Using a soap and water solution, check the air spring valve mounted on the top or side of the shock first.
⇒ If the valve(s) are leaking air, only replace the valves that are leaking.
3. Refer to *Front Air Spring Valve Replacement* or *Rear Air Spring Valve Replacement* in SI.
