# Service Bulletin

Bulletin No.: PIC6629

**Subject: Display Diagnostic Tips and Procedures**

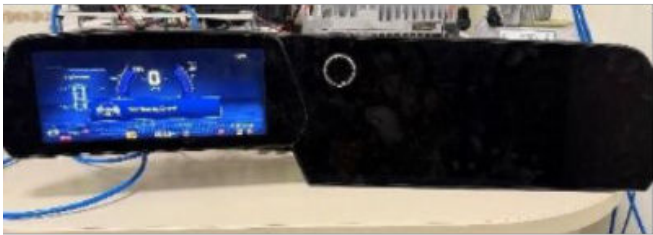
7019596

Below are examples of one, or portion of the display is blank
