# Service Bulletin

Bulletin No.: PIC6629A

**Subject: Display Diagnostic Tips and Procedures**

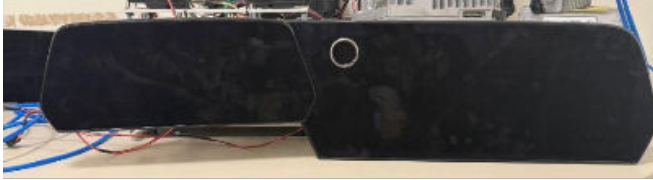
Examples of whole or both displays are blank or black

Verify if the screen is black (appears off), or if a backlight is present on the display refer to specific procedure below based on symptom see pictures below

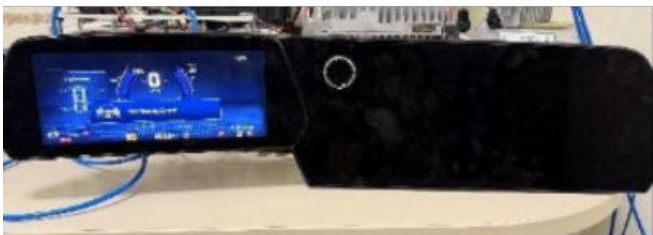
7019596

Below are examples of one, or portion of the display is blank
