Service Bulletin

Bulletin No.: PIT6452

Subject: Poor Heater Performance On Drivers OR Passengers Side

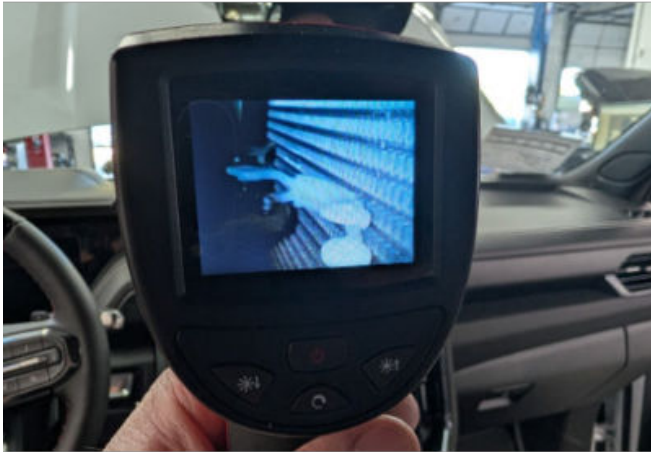
7020910

- Access the view through the upper vents or the HVAC evaporator temperature sensor openings
- Using a borescope, inspect for a disconnected temperature door link.
- Move both the driver's and passenger's temperature doors through their full range of travel while monitoring with the borescope.
- Watch for any binding or resistance that may cause the white temperature door link to separate from the doors or produce a popping noise.

If any door exhibits these symptoms, proceed to Step 2.

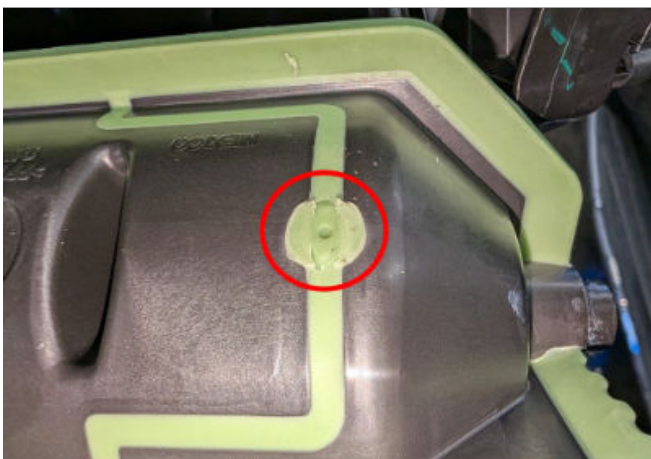
7020911

1. Remove the HVAC case and the temperature actuator for the affected door
- .2. Manually move the door through its full range of travel.
3. If the door strikes the HVAC case, inspect for a high spot in the center of the door, which may result from the injection molding process. (See photo below)

4. Remove the affected door from the air distribution box.
