Service Bulletin

Bulletin No.: PIC6628C

Subject: Windshield to Dash Valence Foam Seal Mis-positioned

Brand:	Model:	Model Year:		VIN:		Engine:	Transmission:
		from	to	from	to		
Cadillac	OPTIQ	2025 - 2026		All	All	All	All

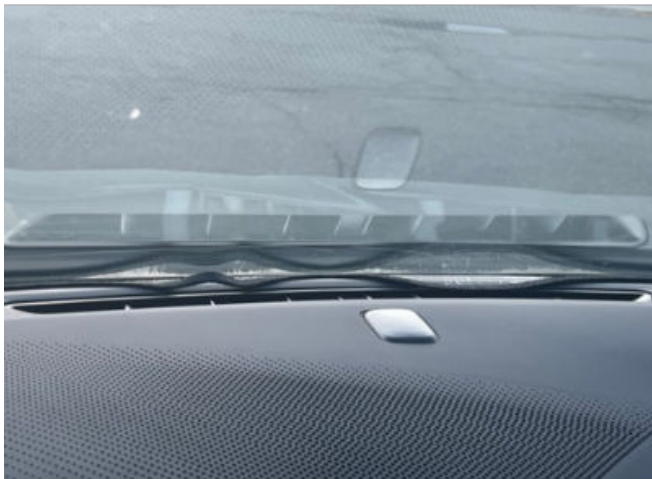
7012512

Involved Region or Country	North America, Canada, Mexico, Europe
Condition	Customers may comment that the foam seal at the base of the windshield, will be visible from either the outside of windshield or from inside the interior when looking at the front of the instrument panel.
Cause	Foam seal adhesive

The foam windshield seal will be visible from either the windshield OR from inside the interior when looking at the front of the instrument panel.
