Service Bulletin

Bulletin No.: PIT6452A

Subject: Poor Heater Performance On Drivers OR Passengers Side

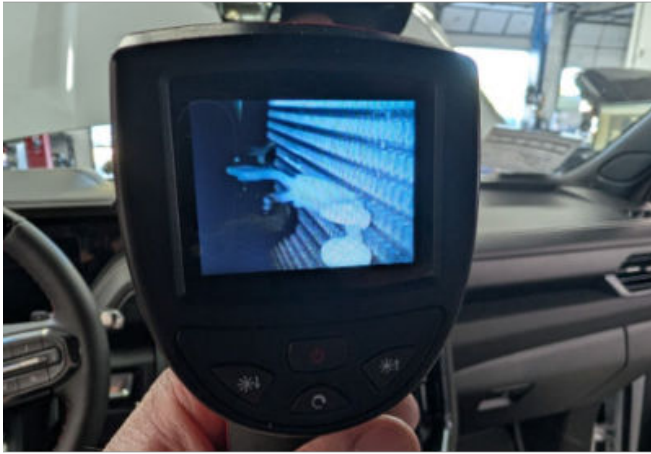
7020910

- Access the view through the upper vents or the HVAC evaporator temperature sensor openings.
- Using a borescope, inspect for a disconnected temperature door link.
- Move both the driver's and passenger's temperature doors through their full range of travel while monitoring with the borescope.
- Watch for any binding or resistance that may cause the white temperature door link to separate from the doors or produce a popping noise.

Note: If one of the white temperature door links has disconnected it can be reconnected after performing the below repairs.

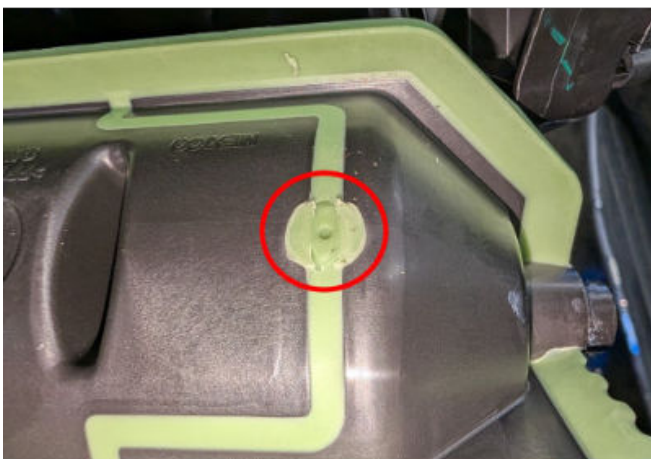
7020911

1. Remove the HVAC case and the temperature actuator for the affected door.
2. Manually move the door through its full range of travel.
3. If the door strikes the HVAC case, inspect for a high spot in the center of the door, which may result from the injection molding process. (See photo below)
